Architecture and Structures of Kiradu Temple (Barmer Region, Rajasthan, India)

Abstract Kiradu temple, known as the Khajuraho temple of Rajasthan, is an epitome of Maru-Gurjara style of architecture. Due to weathering, several sections of the temple complex has been decayed. Though several literatures have mentioned the architectural style of the Vishnu temple of Kiradu, very few work has mentioned the details of other temples existing within the temple complex. In this study we have attempted to understand the architecture and present structural condition of Kiradu. We have studied the strength analysis of one of the partially destructed temple to understand the vulnerability of the fractures. We have tried to look into different fractures and destructed artifacts to understand the real reason of their decay. This study will help us for the preservation and restoration of the temple and to understand the cultural and social lifestyle of the western India during medieval period.

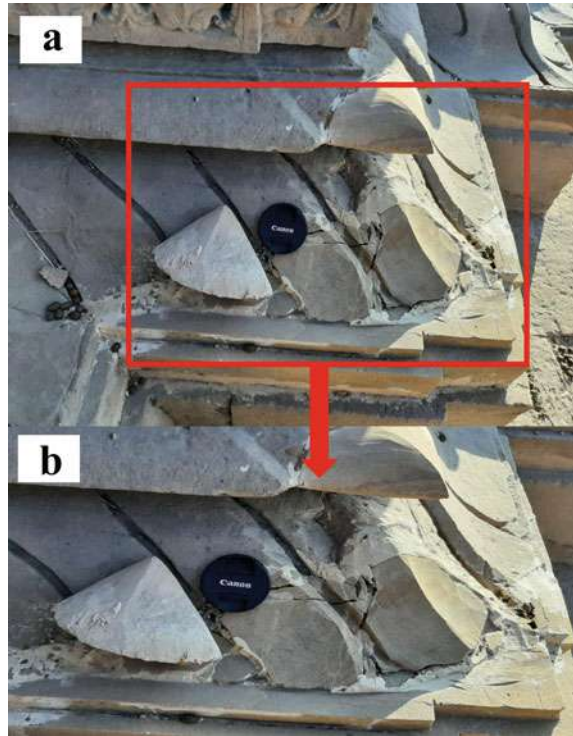
Fig. 9 Restoration of the Shiva Temple (Temple no. 1) (Camera cover marker, diameter 5.4 cm). **a** Restoration work is done in the damaged Jadyakumbha section; **b** restoration done using calcareous cement

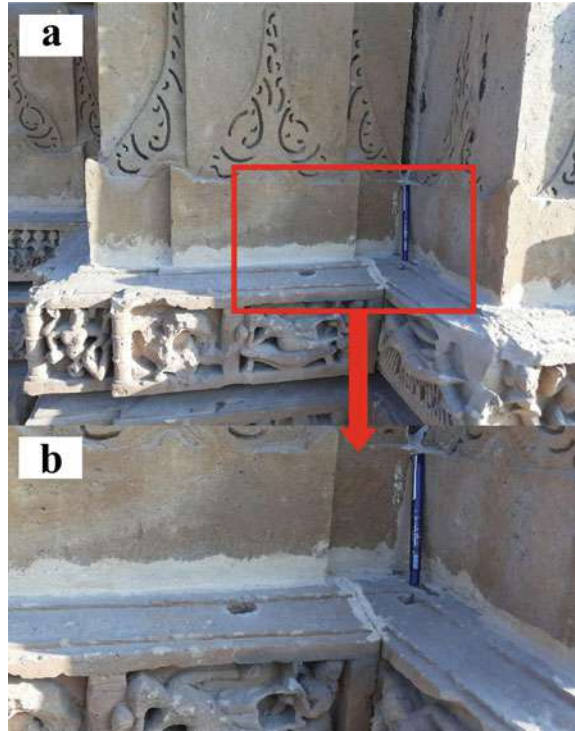
Fig. 10 Adhesive (calcareous cementing material) at the restoration site of the Shiva Temple (Temple no. 1) (Pen marker of length 13 cm) **a** Broken narapitha slab attached with the Khuraka portion with cementing, **b** A broken narapitha slab attached with another such slab with (calcareous cementing material)

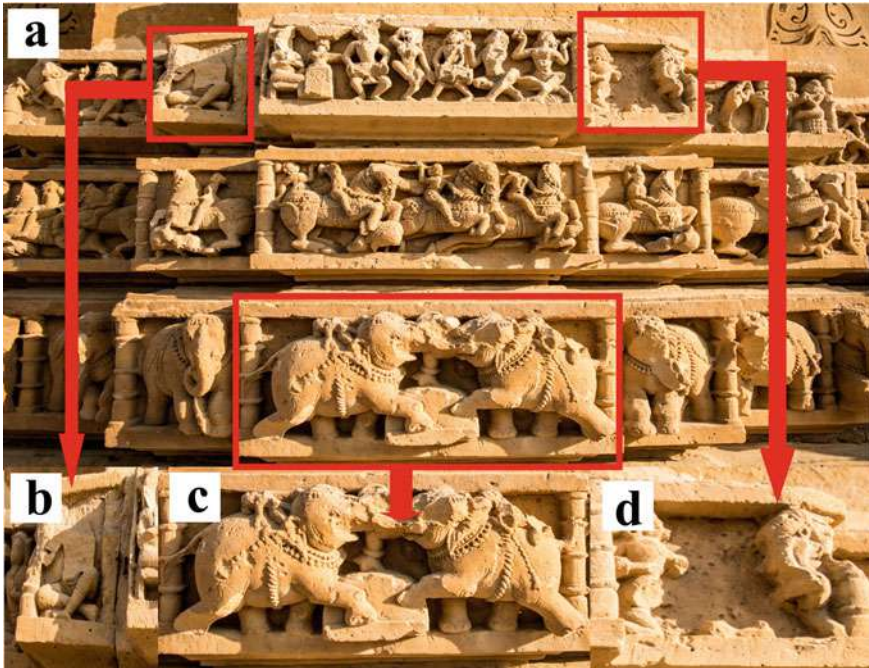
Figure 11a presents damages in the gajapitha, ashvapitha and narapitha slabs. Figure 11b shows destruction of the frontal part of the sculpture. Figure 11c displays that the trunks of the elephants are damaged, and Fig. 11d is clearly shows that the

middle sculpture is completely destroyed. These sections are the elevated portion of the sculptures. So due to weathering these elevated parts were affected most and got damaged. Due to weathering the top part of the Sikhara is also ruined. As Sikhara is the upper part of the temple, this section is completely exposed to the nature and we have observed damages at different sections of the Sikhara. Figure 12a–c show that the frontal part of the sculpture is ruined. Figure 12d displays the damaged part at the back end of the temple.

Fig. 11 Wind erosion affected in parts of the Shiva temple (Temple no. 1), **a** Ruined portions within three different slabs, **b** Frontal part is destroyed, **c** Trunks of the elephants are destroyed and **d** a sculpture is completely damaged

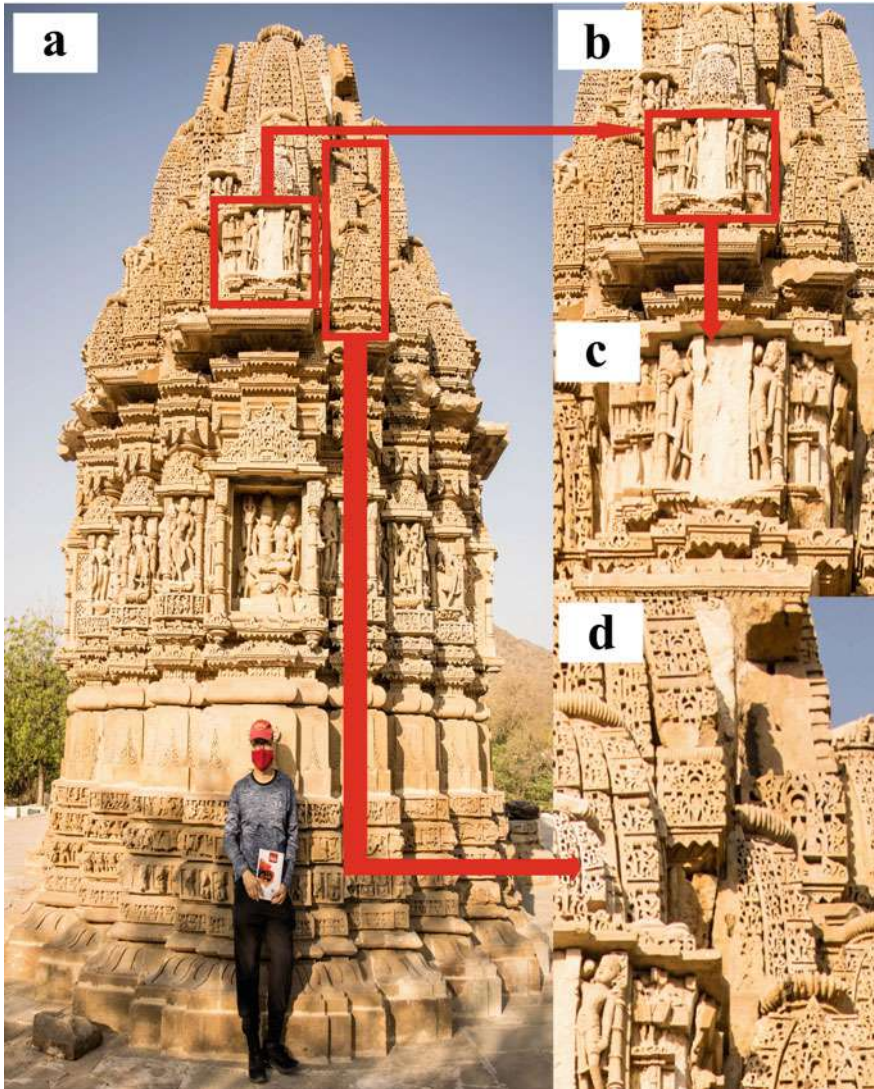
Fig. 12 Top part of the Sikhara of the Shiva temple (Temple no. 1) is completely ruined (Soumyajit Mukherjee as marker), **a** Several part of the Sikhara are damaged, **b**, **c** Frontal sculpture of the Sikhara is damaged, **d** Part of the back of the Sikhara is damaged

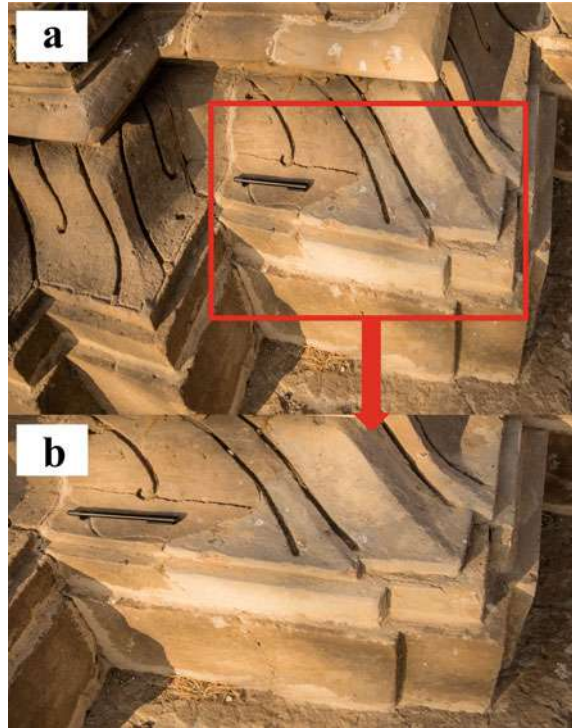
Restoration work done in this temple seems to be a continuous process. As restoration is performed at different time with different materials, color differences at different restoration sections are clearly evident (Fig. 13). In Fig. 13a, the dark yellow color at the bhitta section and pale yellow color at the restored section are observed. Similarly Fig. 13b shows that the color of the restored part is pale yellow, and the unrestored portion is dark yellow at the Jadyakumbha.

Fig. 13 Color difference in the restored section (black pen marker of length 15 cm) (Temple no. 1). **a** Dark yellow color at the Bhatta section and pale yellow color at the restored section, **b** The color of the restored part is pale yellow and not restored portion is dark yellow at the Jadyakumbha

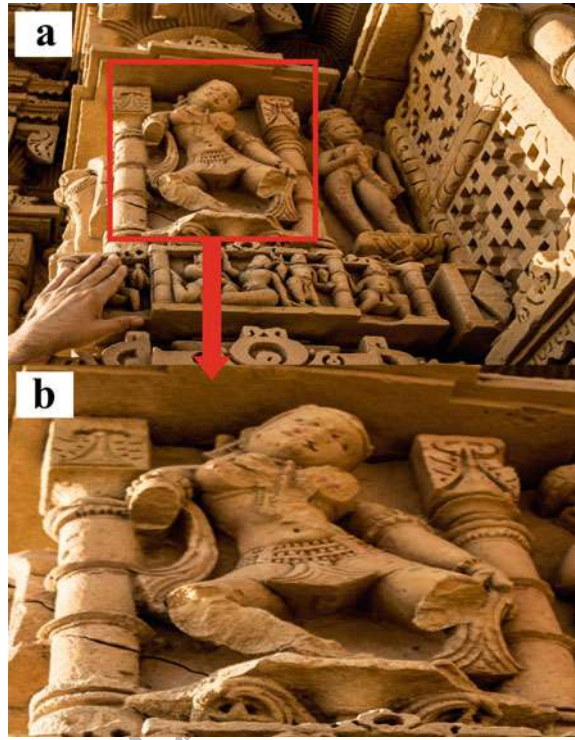
In the Shiva temple, several natural fractures were detected (e.g., Fig. 14). Arms, legs and breasts of the female idols show human-induced damages (Fig. 14b), and this is a persistent observation in the Kiradu temples.

Fig. 14 Natural fracture at the Shiva temple (Temple no. 1) (a) and b arm, legs and breasts are damaged

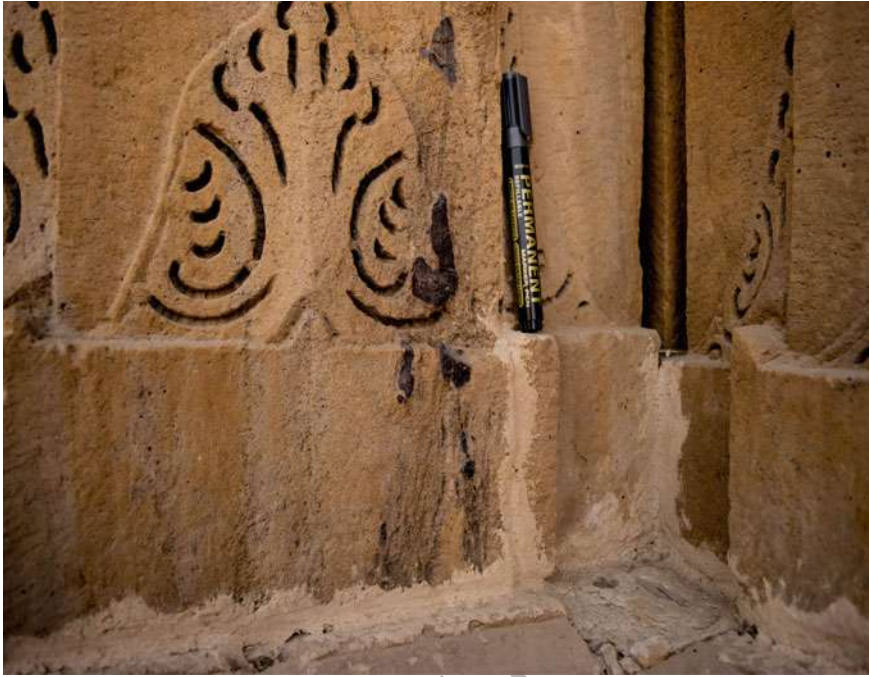
Fig. 15 Restoration of sandstone block (black pen marker) (Temple no. 1) with calcareous cementing material

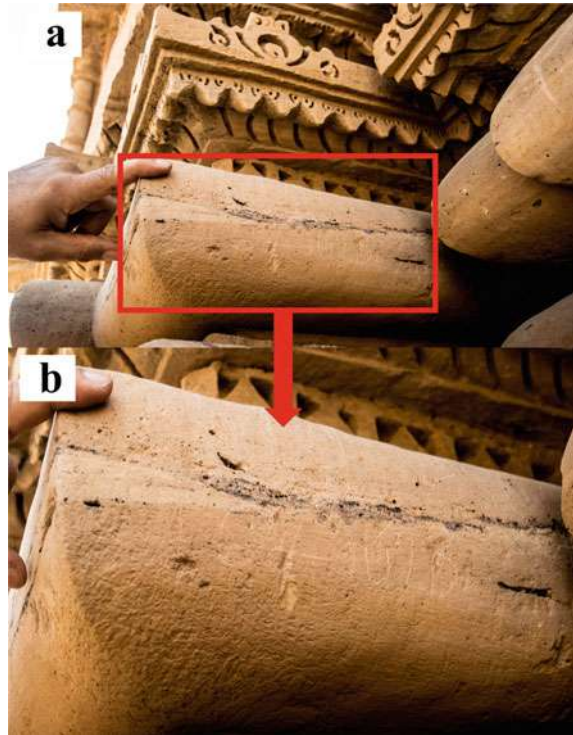
Due to either weak metamorphism or some deformation, foliation planes developed within the sandstone, as observed in few places. The foliation is defined by the preferred concentration of mica along some planar zones (Fig. 17). Such foliation planes act as planes of preferential breakage (Ghosh, 1993), and we note that such pieces of sandstones were not used in any vulnerable portion of the temple. Figure 17b shows a black coloured mineral weakly defining foliation in sandstone. Detail stress-strength analyses, and microstructural studies under an optical microscope would be important to understand the rheology and structures of the sandstone slabs that were used in constructing the Kiradu temples. This can give important constrain on the restoration process. Microorganisms and microchiropterans are very important for damaging any heritage monument. Six species of microchiropterans (*Pipistrillus tenuis*, *Rhinopoma hardwickii*, *Taphozous perforates*, *Rhinopoma microphyllum kinneri*, *Taphozous melanopogon*, and *Taphozous nudiventris*), most commonly known as bats are sited in the temples of Kiradu (Purohit, 2013). These bats induce moisture leading to leaching at the ceiling of the Shiva temple. Figure 18 shows leaching of water in sandstone that was produced by the increased moisture content of the wall created by bats.

Fig. 17 **a** Black mineral grains marking weak foliation in sandstone (finger marker) (Temple no. 1), **b** A line of black material is observed at the surface of the sandstone

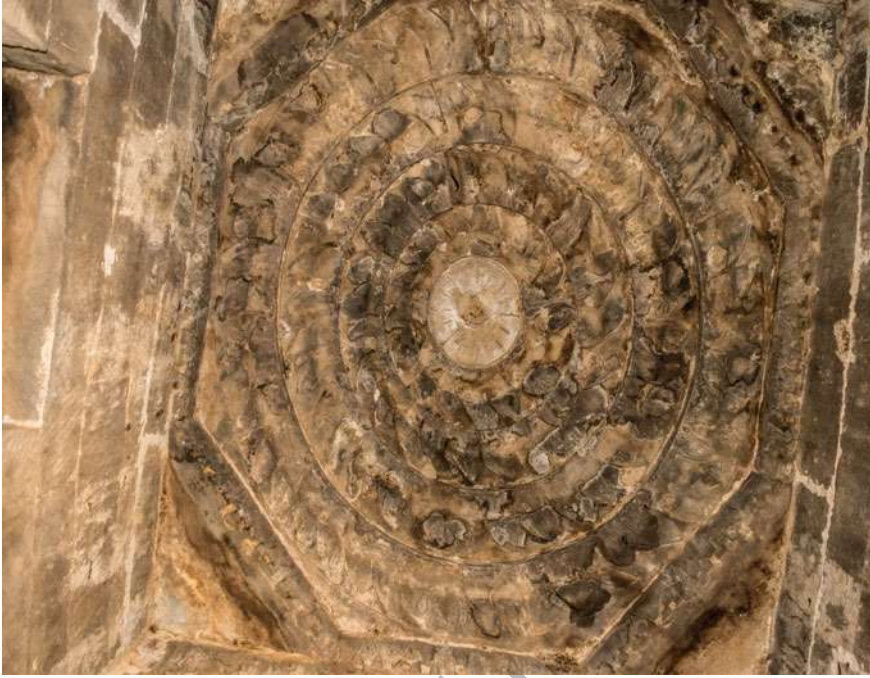
Fig. 18 Leaching of water in sandstone at the ceiling of the Shiva temple (Temple no. 1)

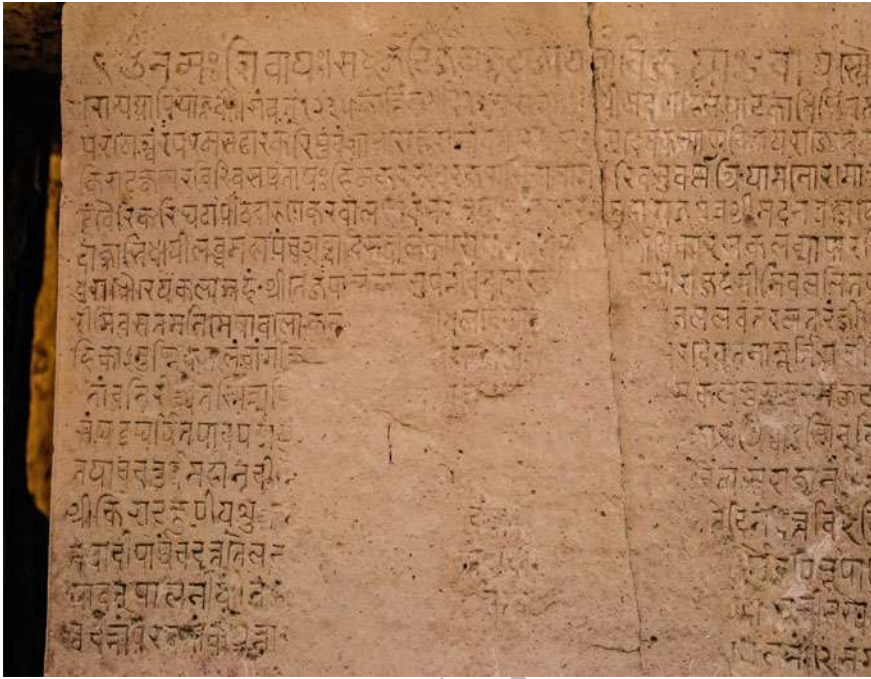
Fig. 19 Partly destroyed inscription at the wall of the Someshwar temple (Temple no. 2)

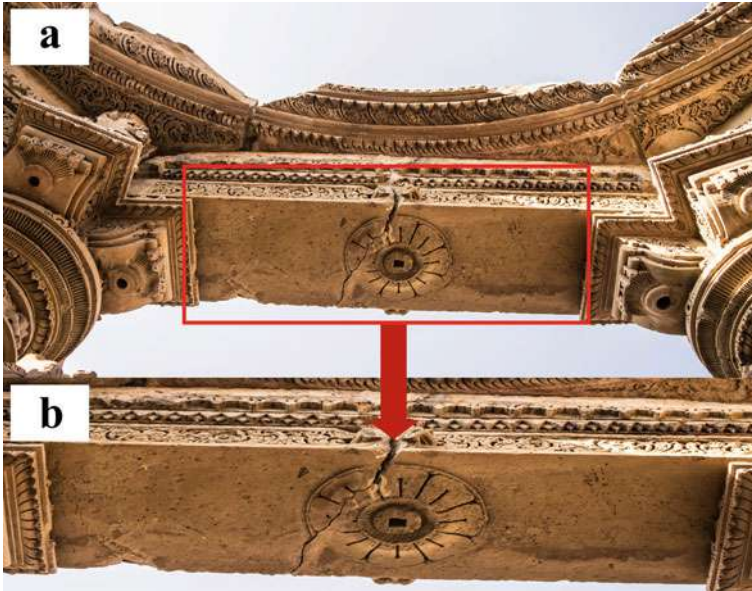
We have observed different types of fractures on the connecting slabs of the pillars forming the Mahamandap (Fig. 21). These connecting slabs are directly exposed to the nature since the Mahamandap has no roof. Natural weathering has created fractures in them. The fractures are quit deep and the slabs are presently in a vulnerable condition. These connective slabs require immediate restoration. Figure 22 exhibits different types of fractures at the top part of the horizontal slabs connecting the

Fig. 21 Fracture at the Mahamandap of the Someshwar temple (Temple no. 2). **a** Fracture at the top part of the connecting slab of the pillars. **b** The fracture is deep and vulnerable

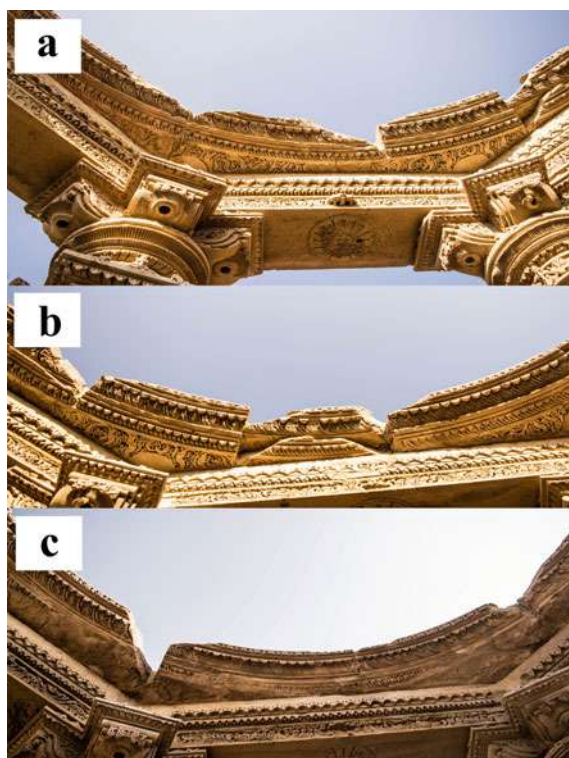
Fig. 22 Different types of fracture at Mahamandap of the Someshwar temple (Temple no. 2). **a-c** Fractures at the top part of the ligands connecting the pillar of Mahamandap

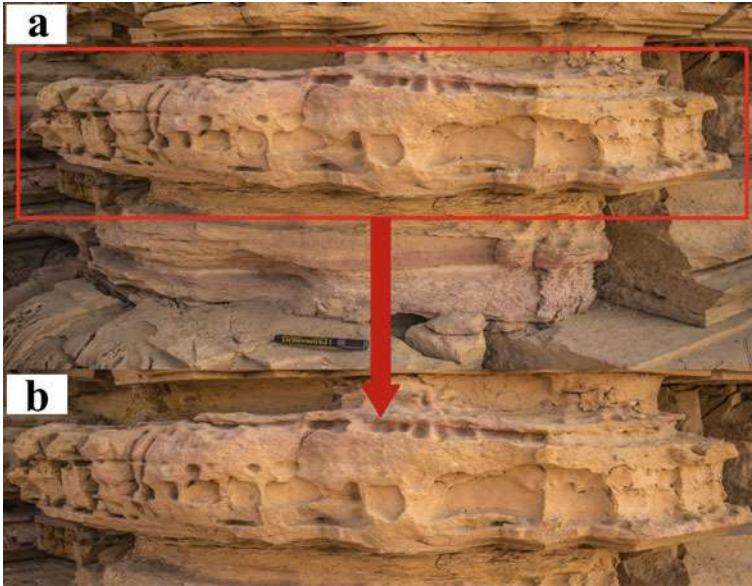
pillars. Natural fractures are also observed at the temple wall (Fig. 23a). Water-induced erosion has created ~2 cm deep cavities in sandstones, giving rise to finally honeycomb appearance (Fig. 23b). In Rep. Fig. 2, the Talchhand section (From the entry gate to the gate of Garbhagriha) is illustrated.

Fig. 23 **a** Natural fracture at the wall of the Someshwar temple (Temple no. 2) (black pen of length 14 cm), **b** Weathering of the wall producing a honeycomb geometry in sandstone

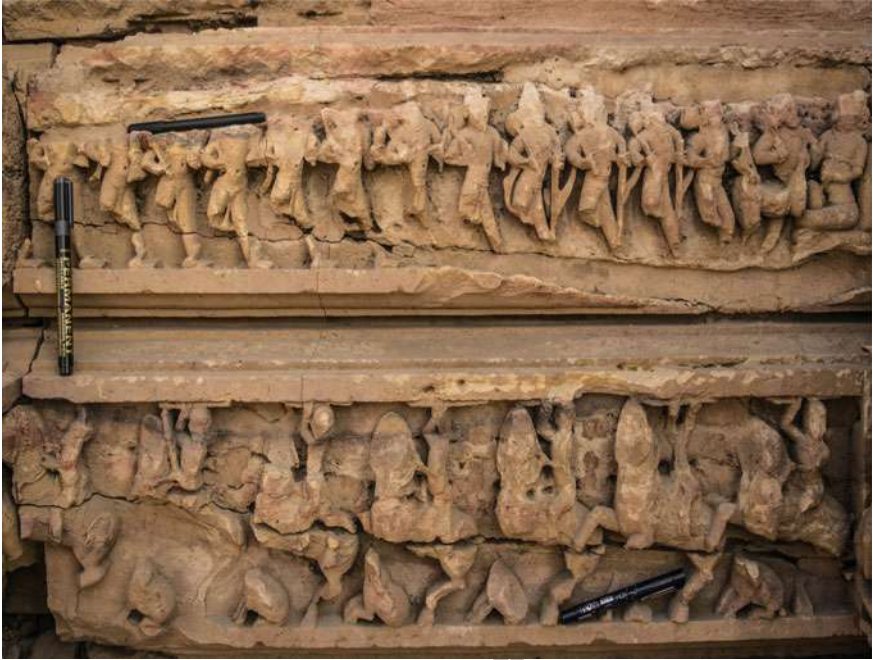
Natural erosion has also observed at the wall of the Someshwar temple. Figure 24 presents the erosion of the wall. In this figure, the top portion of the left side of the slab is more damaged whereas the right side is more intact. This can occur due to direction of wind flow along a specific direction. In the lower section of this slab, we can observe that the sculptures are decayed due to water clogging. The natural decay at the wall of the Someshwar temple clearly indicates that we need a detail defect and stress distribution study of the temple rocks. The sandstones used to construct the Someshwar temple shows grain size variation in few places (Fig. 25a). In Fig. 25b, the fine grained softer particles are pink, whereas the harder coarse grains are yellow.

Fig. 24 Weathering of the Someshwar temple wall (Temple no. 2) (black pen of length 14 cm)

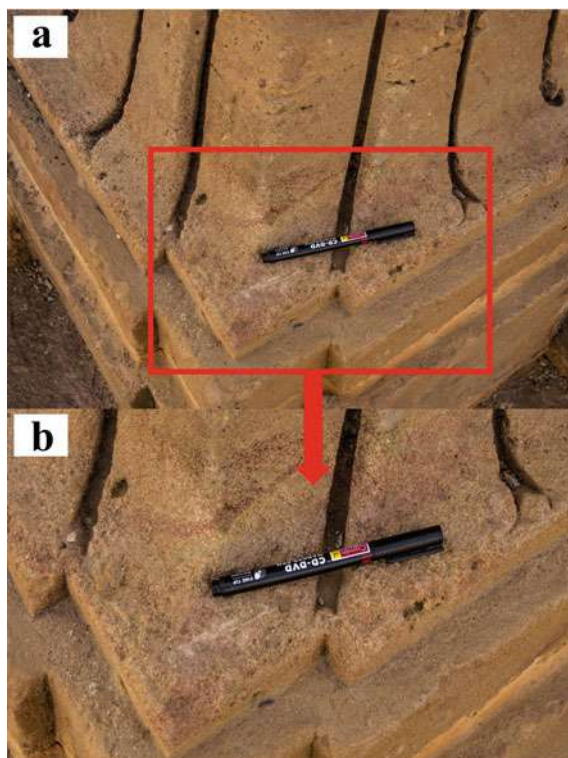
Fig. 25 **a** Grain size difference noted at the wall of the Someshwar temple (Temple no. 2) (black pen marker of length 14 cm); **b** coarse and fine grain within the sandstone are clearly distinguished

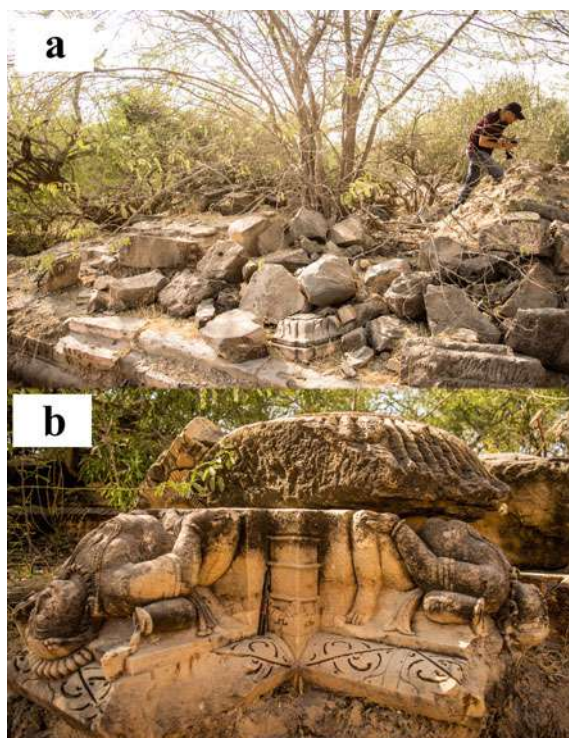
Fig. 26 a Completely destroyed temple (Temple no. 3). b Fragmented pillar of Mahamandap (black pen maker kept in between the two vandalised statues (Temple no. 3))

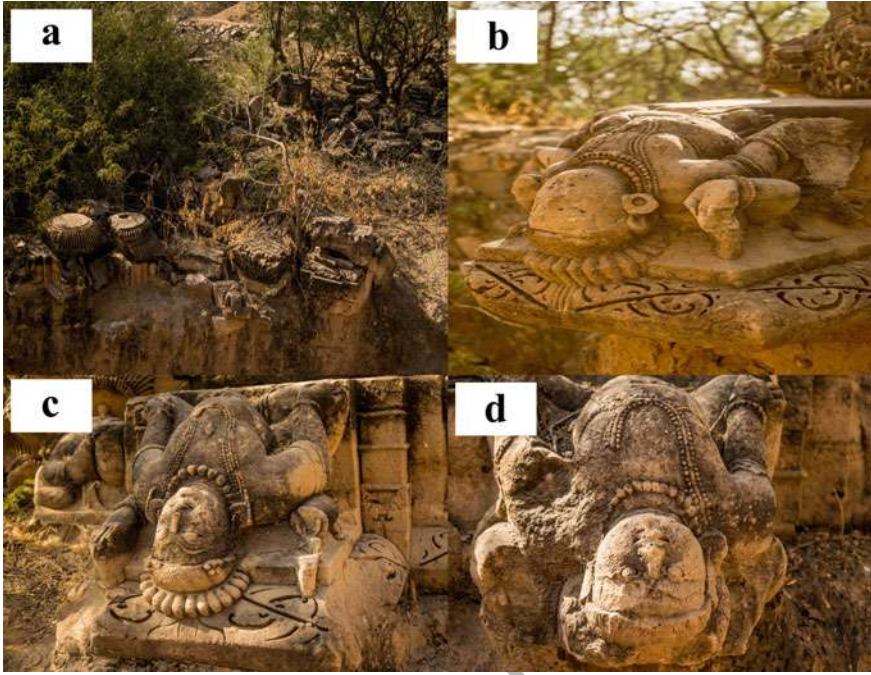
Fig. 27 a Scattered part of completely destroyed temple (Temple no. 3), **b–d** Demolished part of the pillars (Temple no. 3)

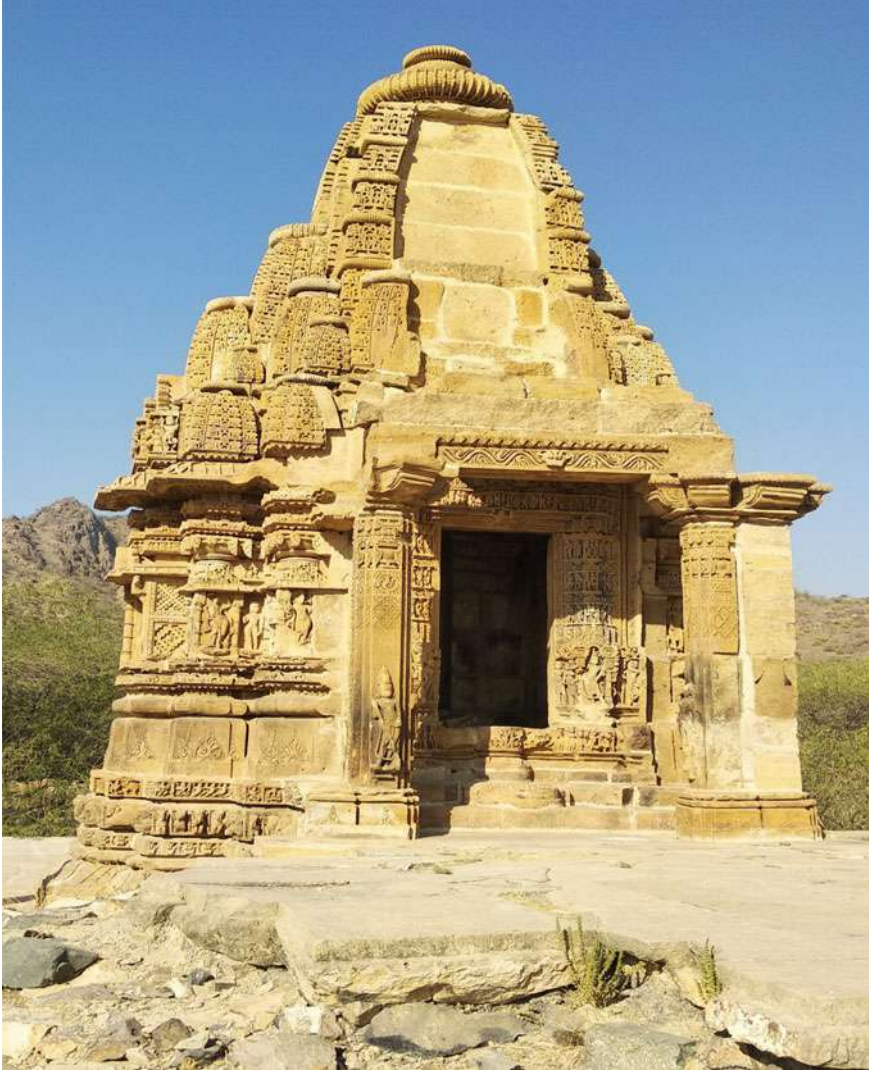
Temple no. 5 is also a partially preserved Shiva temple (Rep. Fig. 5). In this figure it is clearly evident that the temple sanctum without Mahamandap where the Sikhara is damaged and some parts of the pillar sections have been restored.

Rep. Fig. 5 Frontal image of the partially damaged Shiva temple (Temple no. 5)

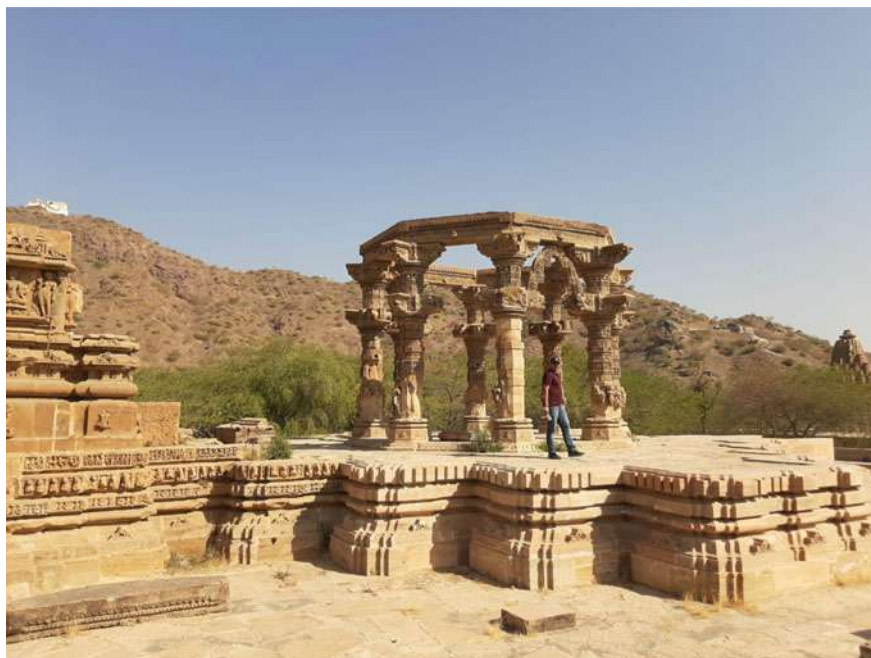
Fig. 30 Vishnu Temple (Temple no. 6). Only Mahamandap is remaining and Garbhagriha is also in damaged condition

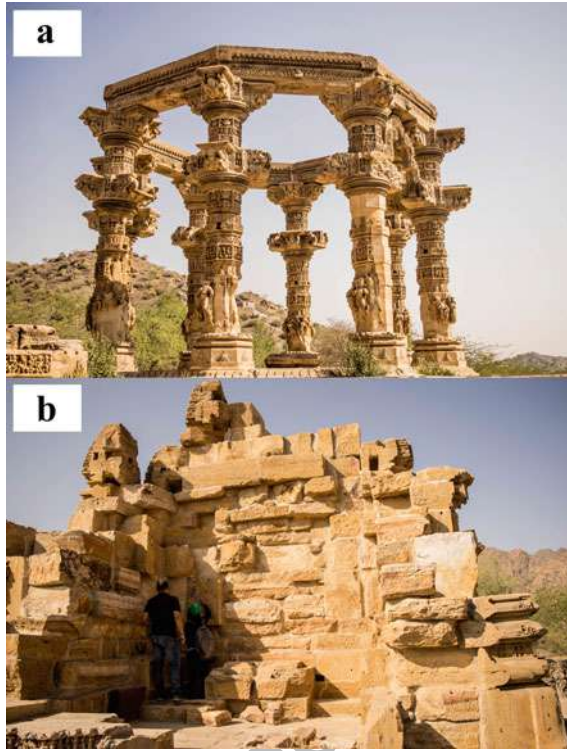
Fig. 31 Vishnu Temple (Temple no. 6). **a** Only Mahamandap is remaining, **b** Garbhagriha is completely ruined

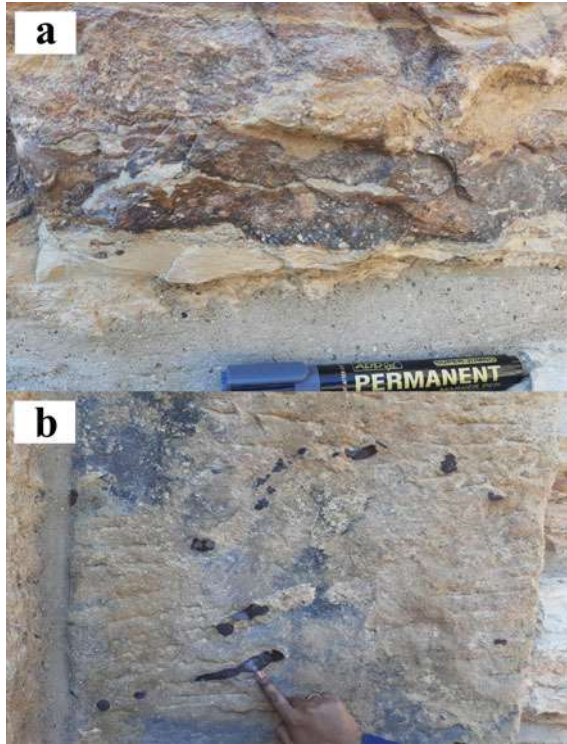
garbhagriha, brown patches are spotted within the sandstone (Fig. 33a, b) A chemical analysis is needed to fully understand the composition of the sandstone.

Fig. 33 **a** Presence of iron within the sandstone brown in color (black pen marker), **b** brown patches, possibly indicating iron (finger marker) at the wall of the Garbhagriha of Vishnu temple (temple no. 6)

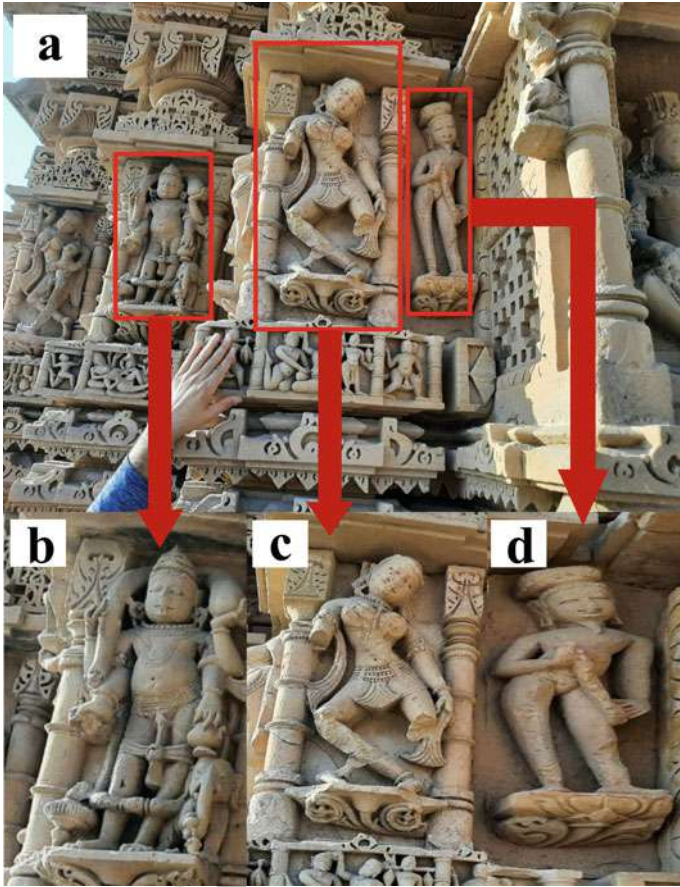
Fig. 34 a Only female statues are vandalized at the Shiva temple (Temple no. 5) (hand as marker), b sculpture of man idol is intact, c hand, legs of the female idol are damaged. d Sculpture of man idol is intact

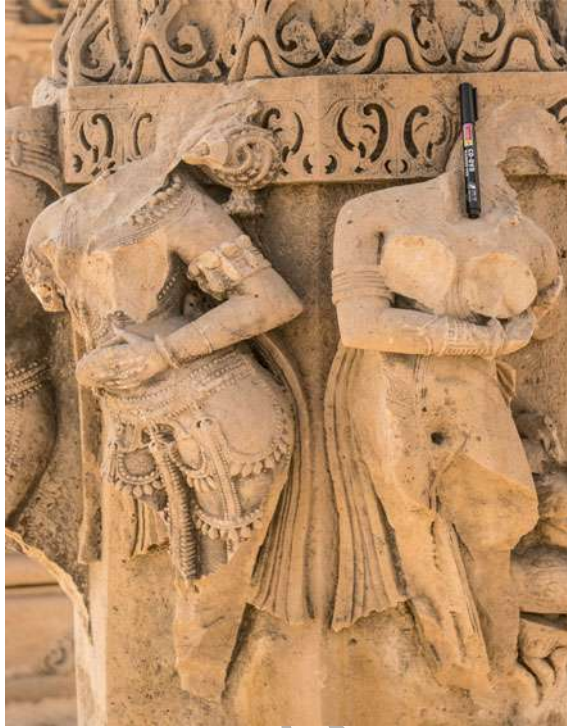
Fig. 35 Only female statues are vandalized at the Shiva temple (Temple no. 5) (black pen marker of length 14 cm)

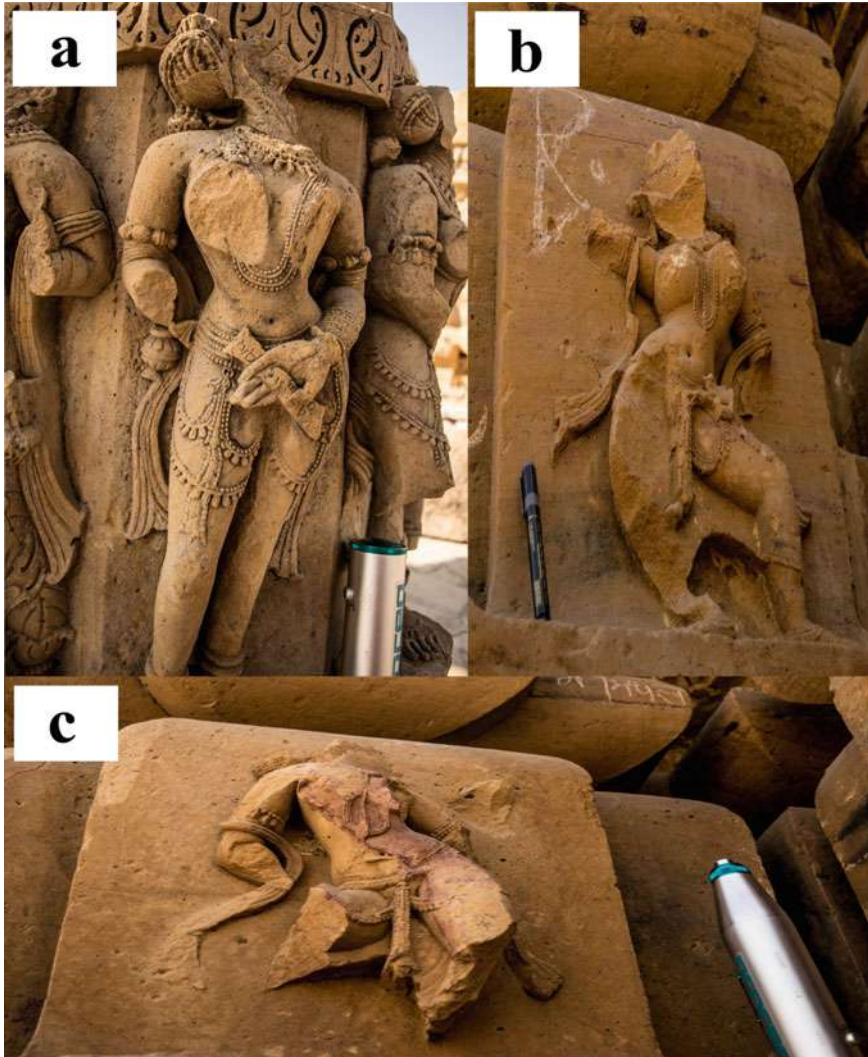
Repository Figure 8 represents vandalized female statues in the Shiva temple (Temple no. 4). In figure Rep. Fig. 8a head and chest part of the female body are defaced. Repository Figure 8b shows that head and leg part of the female sculpture are ruined. Similarly Rep. Fig. 8c manifests that head, breast, hand and leg part of the female idol are completely broken.

Rep. Fig. 8 Female statues are damaged due to act of vandalism at the Shiva temple (Temple no. 4) **a** Head and breasts destroyed (Smith hammer marker), **b** Head and leg of the female idol are ruined (black pen marker of length 14 cm), **c** Head, breasts, hands and legs of the female idol are broken (Smith hammer marker)

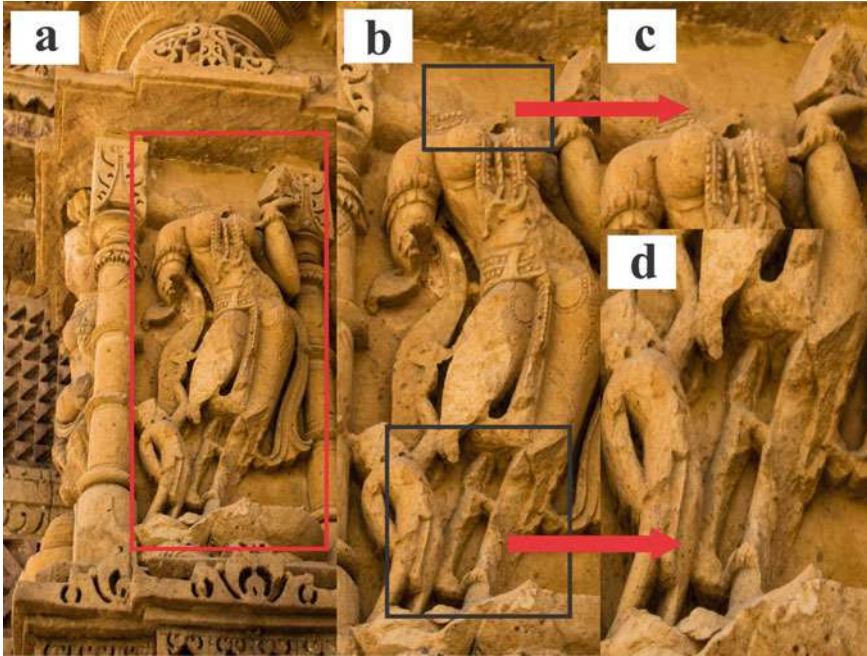
Rep. Fig. 9 a Female statue is damaged due to act of vandalism at the Shiva temple (Temple no. 4), b Head, hands and leg parts destroyed

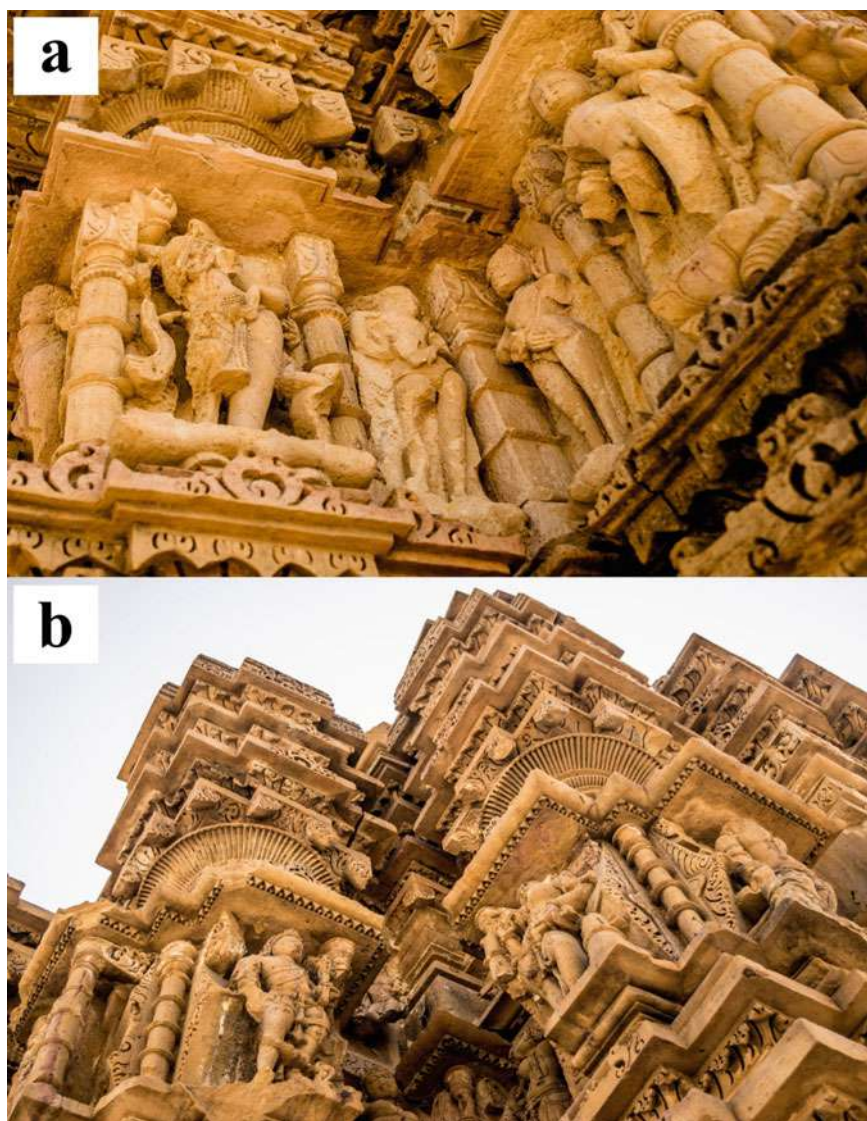
Rep. Fig. 10 a, b Female statues are vandalized at the Shiva temple (Temple no. 4)

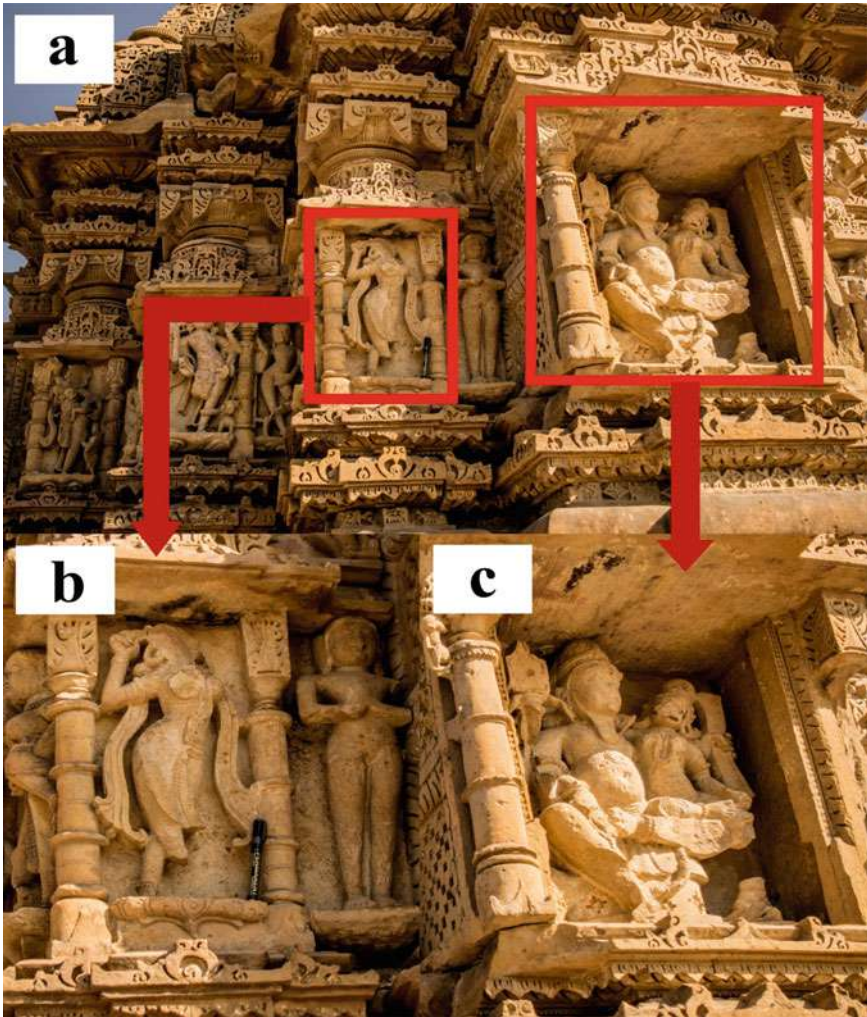
Rep. Fig. 11 a Only the female statues are vandalized at the Shiva temple (Temple no. 5), b Head, breasts, hand and leg are defaced of the female idol, c An idol of a man is not damaged

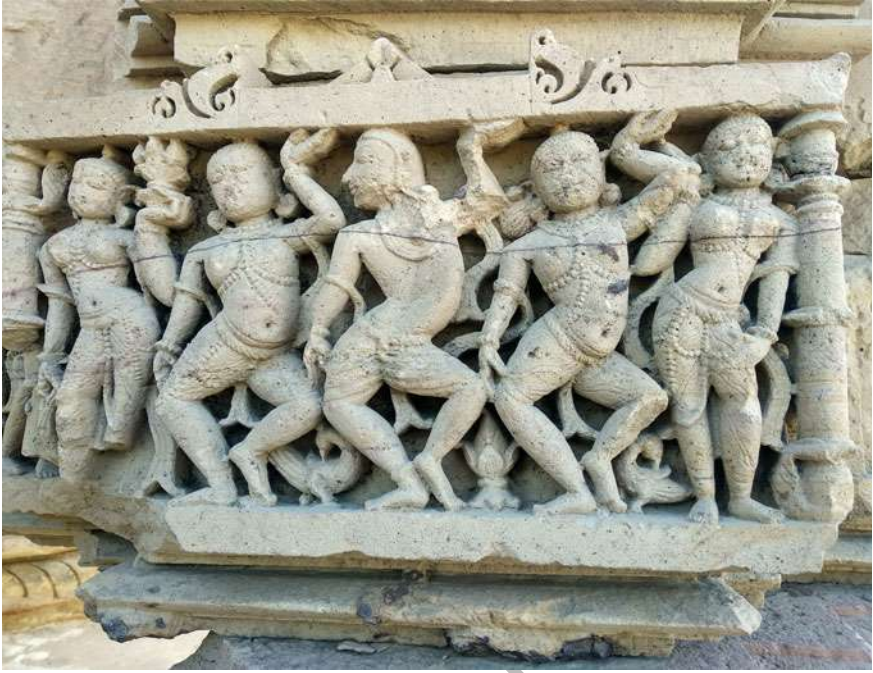
Fig. 44 Through going fracture cutting all the idols

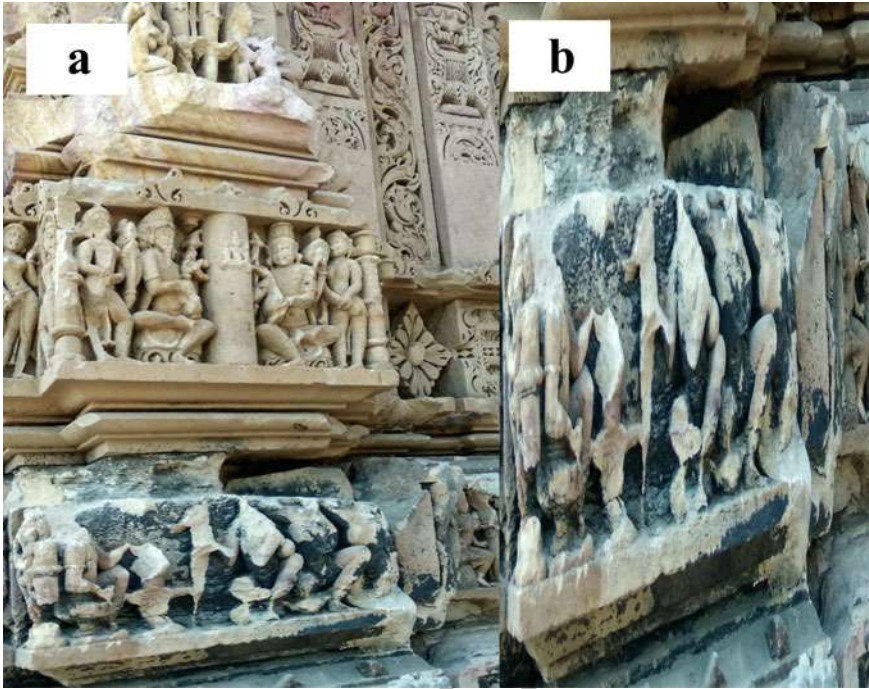
Fig. 45 Almost destroyed sculpture by natural erosion
