Structural Geology and Stability Issue of the Giral Lignite Mine, Rajasthan, India

Abstract This field study is focused on normal faults and tension cracks of the Giral lignite mine, Barmer basin Rajasthan (India). Besides normal faults, lignite cleat and bedding data have been collected. Cleats and beddings are perpendicular to each other and filled with salt at the northern portion of the mine. Two normal faults are first time documented in the Giral mine, those can be related to initiation of strike-slip movement between India and Madagascar and main Barmer rifting. F1 fault group has trend NE–SW and F2 trend in approximately E–W. Due to the persence of these faults, northern slope of the mine shows slope failure. This slope failure can be seen on the plan view in the form of multiple stages of tension cracks. Fractured block on the slope show horizontal and vertical rotation towards N112° with 10–30° inclination. To find out the detail solution of the mine slope failure, more detail study is required.

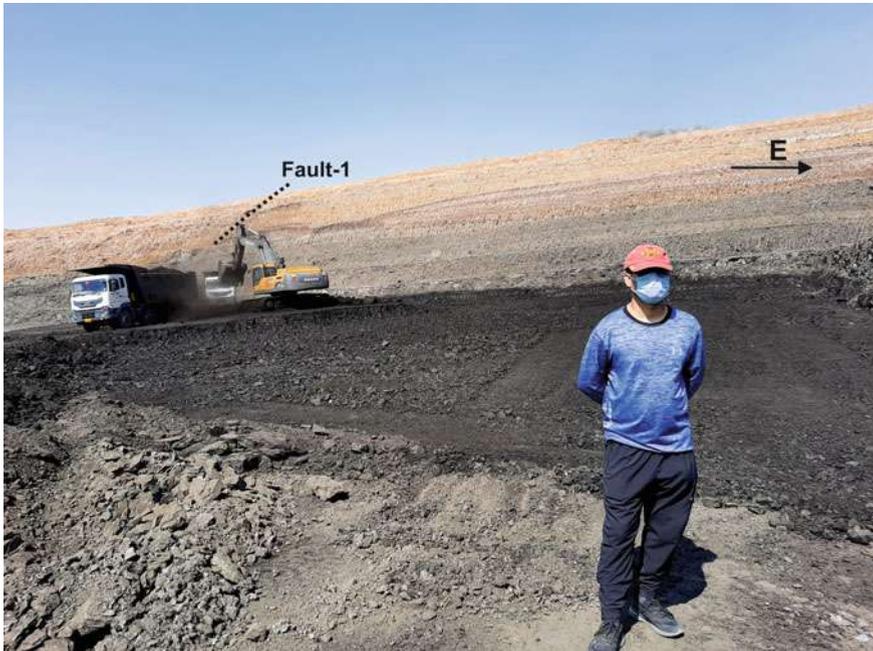
The Giral mine is destabilized locally by two normal faults those trend NW–SE (F-1 and F-2) and can be observed at the northern portion of the mine (Figs. 1b and 2). These faults have same trend as rift fracture in the Barmer Basin (Dasgupta and Mukherjee, 2017). These faults are new report in this study. In this mine alternate layers of lignite and shale are observed (Fig. 3b). Bedding of the lignite and shale dips

Fig. 2 Expression of fault on north face of the Giral lignite mine trending NE-SW. S. Mukherjee (170 cm) as marker

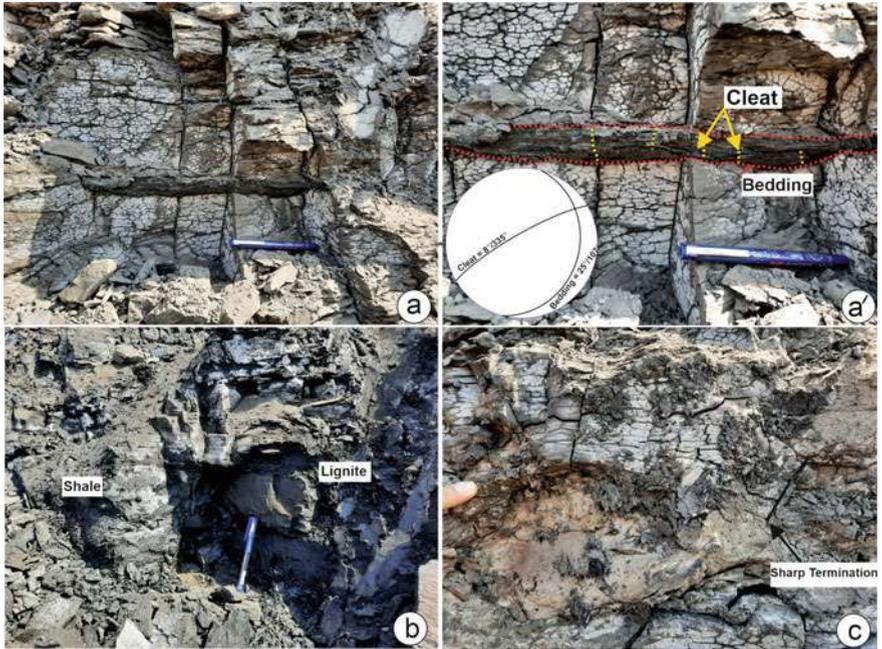
25° towards $N107^\circ$ direction. Cleats are near-perpendicular to the bedding planes and dipping towards $N335^\circ$ with dip amount 80° (Fig. 3a, a'). Few $N035^\circ$ trending sub-vertical joints almost orthogonal to the cleat sharply terminate against the shale bands (Fig. 3c).

Fig. 3 Field photographs of Giral mine at location-1; **a** cleat and bedding structures structure original **a'** and with interpretation, bedding planes are well observed dipping towards N107° and inclined at an angle 25°; cleats are near-perpendicular to the bedding. Cleats strike N075° and dip towards N335°; **b** alternate bands of shale and lignite, pen (12 cm) as scale; **c** sharp termination of vertical joint in lignite against the shale with trend N035°, part of finger (2 cm) as scale

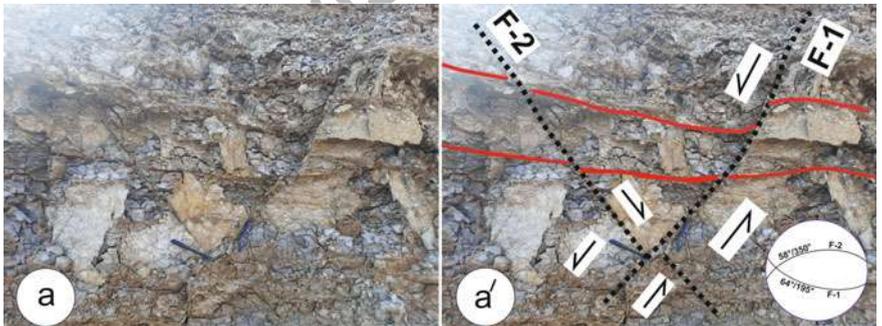
As observed in a sub-vertical section inside the mine, F-1 and F-2 form a graben structure in the mine area (Fig. 4). F-1 dips 64° towards $N195^\circ$, and F-2 dips 58° towards $N350^\circ$ (Fig. 4).

Fig. 4 Field photographs of Giral lignite mine show graben structure on a vertical plane, at location-5. **a** uninterpreted, and **a'** interpreted image., Fault-1 dips 58° towards N350°. Fault-2 dips 64° towards S015°. Brittle planes filled up by secondarily precipitated salt in the eastern portion of the mine at location-1. Pen (12 cm) as scale

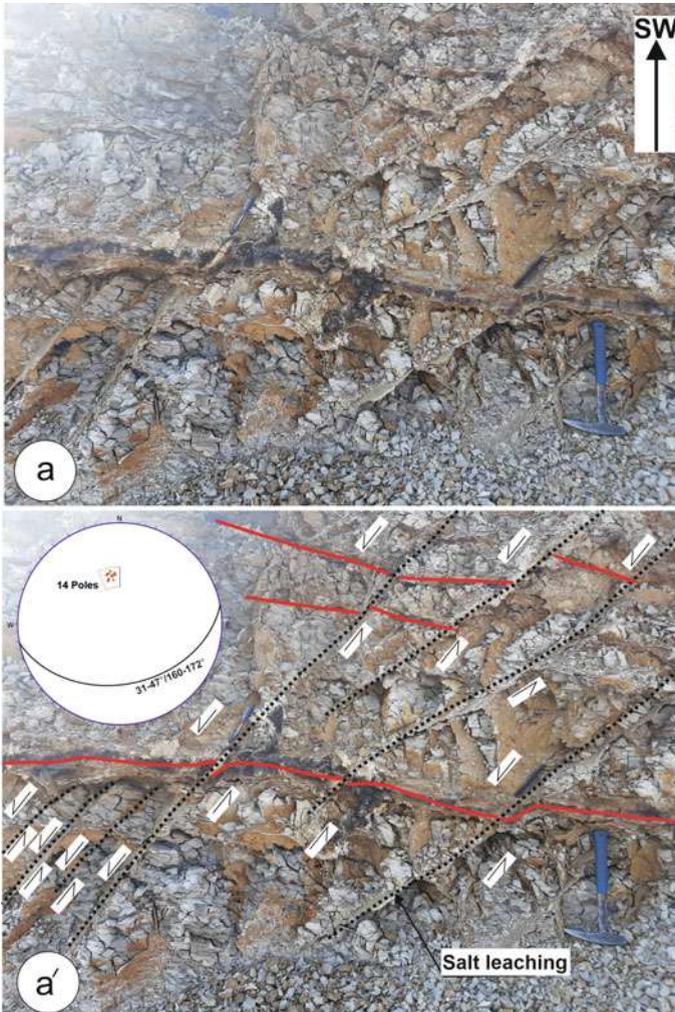
The mine has been excavated ~ 120 m deep from the initial ground level. So the stability of the bench and berms are highly controlled by the sets of normal faults in the mine area. Parallel sets of normal faults (parallel to F1 dip direction ranges $N160\text{--}195^\circ$) intersect the beds of lignite and shale at location-6 (Fig. 5). Total 14 such normal fault planes are observed within 1–2 m long outcrop at the berm and they dip $31\text{--}47^\circ$ towards $N160\text{--}172^\circ$ (Fig. 5a'). Lignite deposit in this area shows ductile deformation before the brittle deformation in the form of normal faults. This ductile deformation is preserved in the form of asymmetric folding and later superposed by brittle deformation (Fig. 5a, a'). Asymmetric folds show top-to- $N011^\circ$ (NE) shear and terminate against the normal fault with $N191^\circ$ dip direction at location-7 (Fig. 6). Secondary mineralization of salt along the brittle planes is common in the northern portion of the mine (Fig. 5 and 6).

Fig. 5 Field photographs of Giral lignite mine area shows a vertical section with parallel normal faults at location-6; (a) and with interpretation (a'), the 6–9 cm thick lignite seam faulted by parallel normal faults dip 31–47° towards N160–170° at the eastern portion of the mine at location-2. Hammer (30 cm) as scale

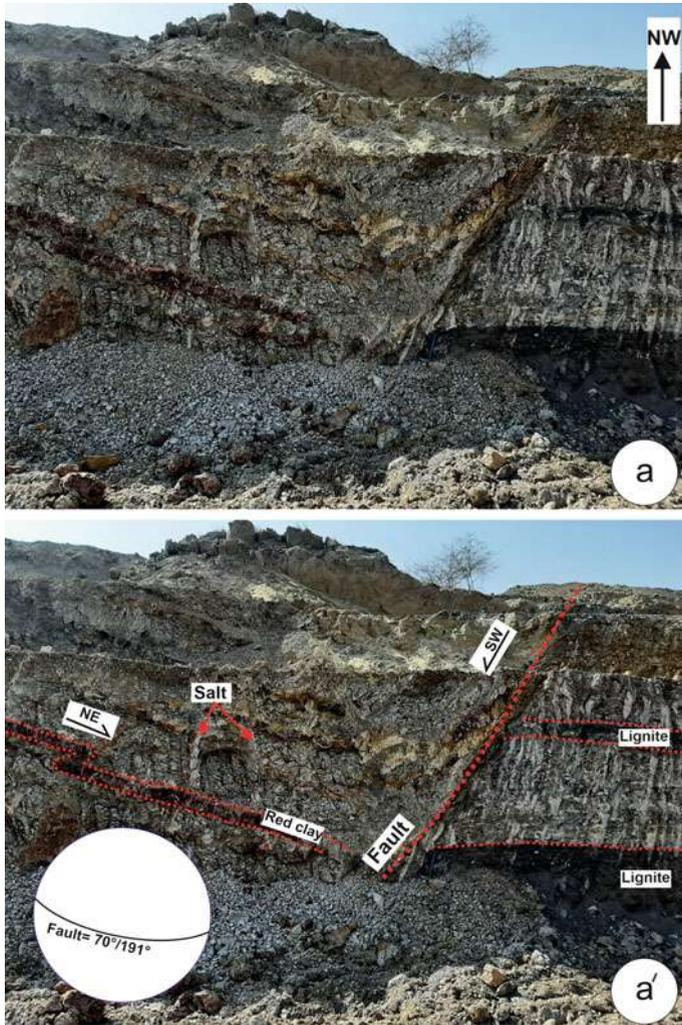
Fig. 6 Field photographs of Giral lignite mine show on a vertical plane parallel normal faulting with 'z' shape fold at location-7 (a) original and with interpretation (a'), a 'z' shape fold shows top to N011° shear direction in folded red clay band. A steeply-dipping (70°) normal fault with dip direction N191° cuts the early deformed beds. Secondary precipitation of salt along joints is present. The joints dip 75–80° towards N190°. Geological hammer (30 cm) as scale

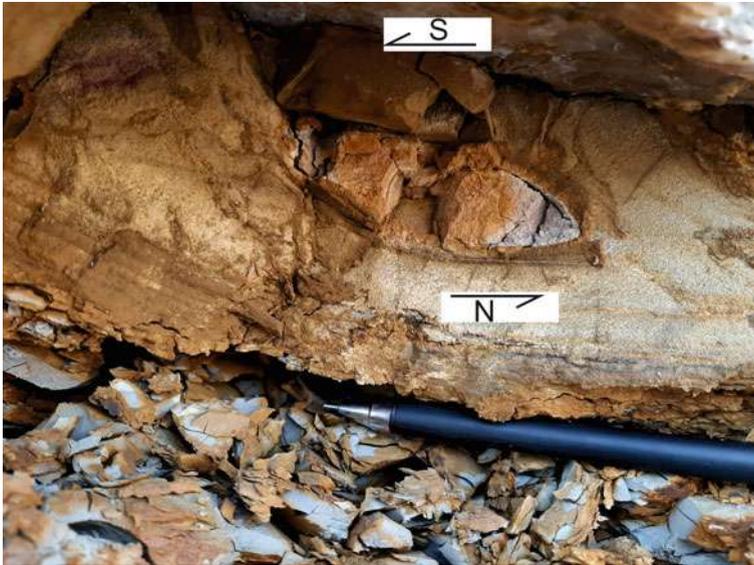
At the footwall of the faults (Fault 1) asymmetric boudins show a top-to-South slip (Fig. 7) at location-4. A few “random” normal faults are also observed, dipping 58° towards N085° (Fig. 8).

Fig. 7 A rootless clast of a boudin with top-to-S slip, location-4, observed on a vertical exposure. Part of pen (8 cm) as scale

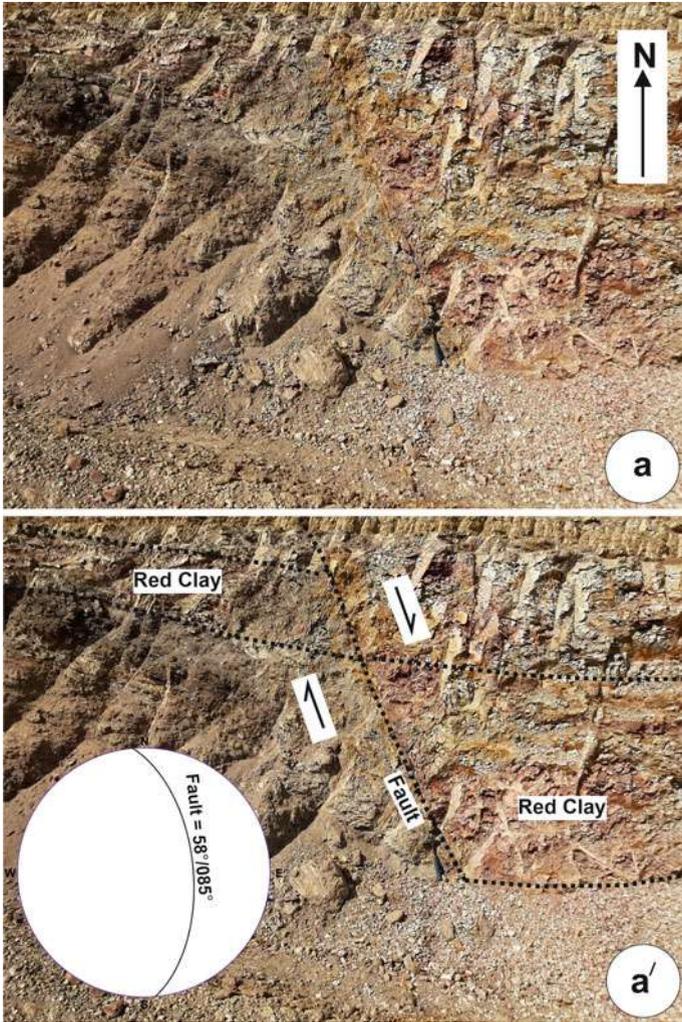
Fig. 8 Field photographs of Giral lignite mine area (**a**—uninterpreted and **a'**—interpreted) shows in a sub-vertical section a normal faulting in red clay bed. The fault dips 58° towards $N085^\circ$ at location-6. Hammer (30 cm) as scale

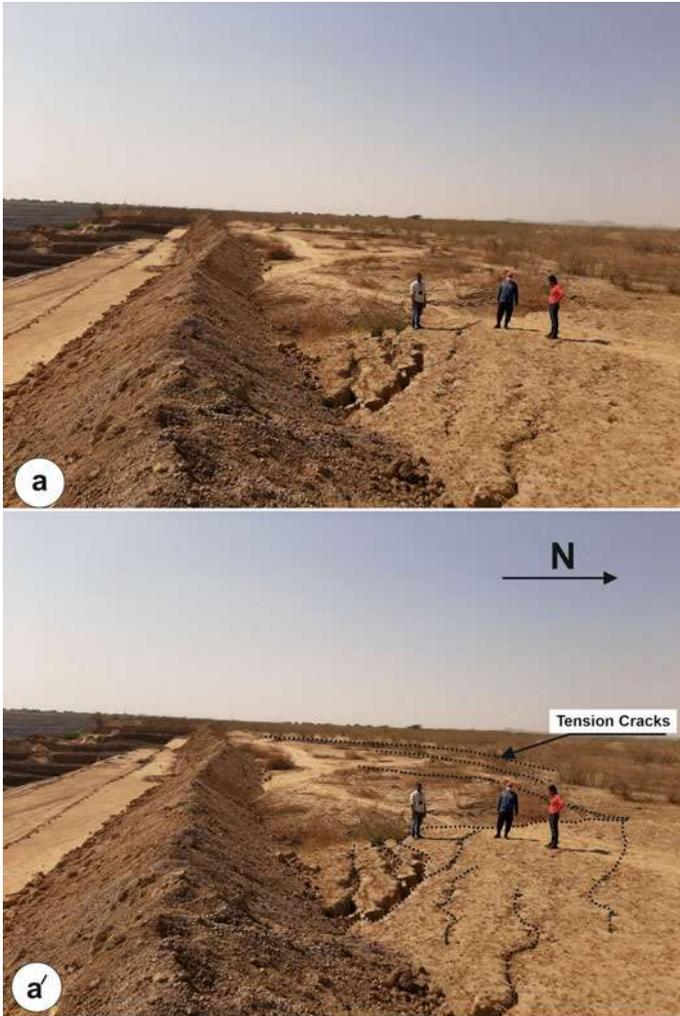
Faulting, lignite mining and leaching of groundwater at the northern portion of mine promote ground failure. The failure is evident in the form of tension cracks at the northern portion of the mine as observed on the ground surface, i.e., on the plan view (Fig. 9). These cracks are sub-circular and show multiple stages of failure.

Fig. 9 Field photographs of Giral lignite mine of Northern slope shows parallel tension cracks of different stages at locations 2 and 3: **a** uninterpreted, and **a'** interpreted. Tension cracks have developed. Few fractured (cracked) blocks have rotated

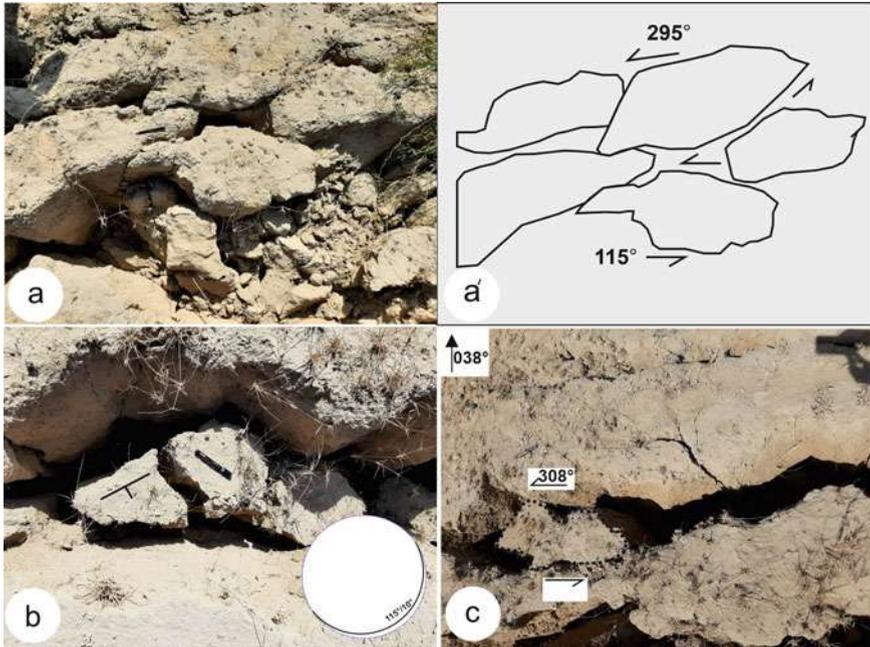
Fractured blocks show horizontal and vertical movement. Horizontal left-lateral slip along N295 to 308° is deciphered with the help of curved fractures (Fig. 10a, c). Vertical and rotational movement are preserved. Difference in inclination of the adjacent fractured blocks indicates their rotation (Figs. 10b and 11). The inclination of rotated planes varies from 10 to 30° towards N115° (Fig. 10b). Vertical displacement varies from 10 cm up to 0.7 m at different levels (Fig. 11a, b). From north towards the western crown of the mine, detached block's orientation change from N112 to N210° (Fig. 11). This is due to the change in the direction of slope. Besides structural data, angle of the berm is also responsible for the mine slope stability. In this mine the angle of berm is varies from 78 to 85°. The angle of berm is very steep at northern portion and elevation difference between ground and mine deepest part is > 100 m. The width of bench also varies from place to place. At some places, it is 5 m and at elsewhere 8 m.

Fig. 10 Field photographs of tension cracks on plan view at location-2. **a** uninterpreted; **a'** interpreted: curved fractures probably show left lateral shear (left hand side N295°); **b** detached irregular block is rotated and dips 10° towards N146°; **c** possibly left laterally sheared curved fractures (left hand side N308); Pen (12 cm) as scale

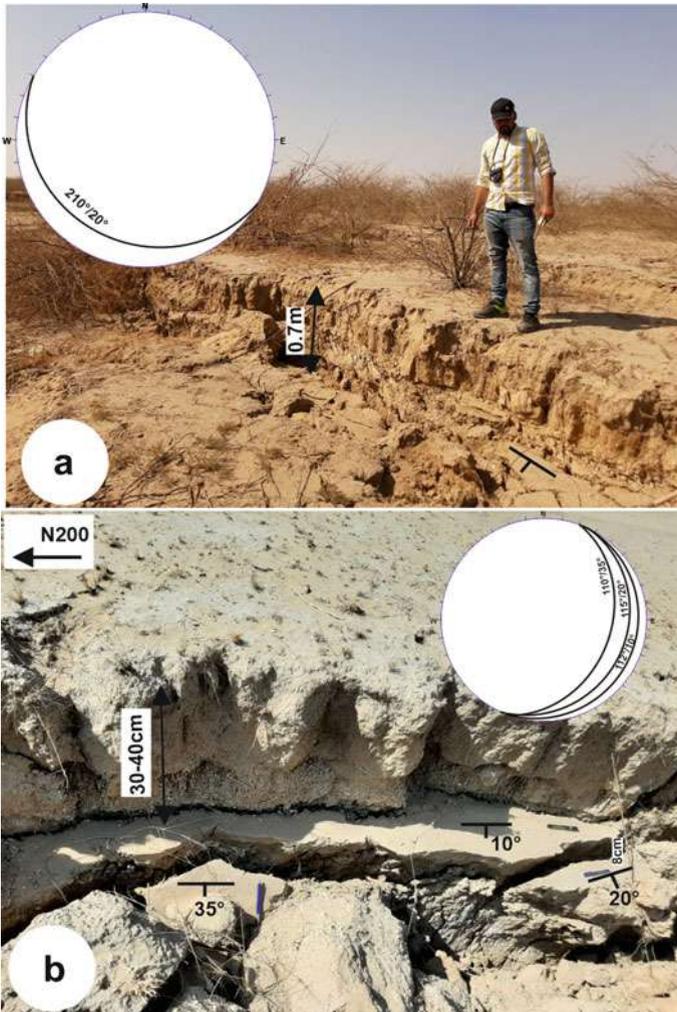
Fig. 11 Field photograph of Giral lignite mine at location-3 shows parallel tension cracks, fractured planes dip at different angles; **a** detached plane shows 0.7 m throw and fractured plane dips 20° towards N210°; **b** 30–40 cm throw observed along the slip plane, this plane dips at 10° towards N112°. Another slip plane shows 8 cm throw and dips 20° towards N115°. The third plane shows a maximum inclination of 35° towards N110°. Pen (12 cm) as scale

- The faulted northern portion creates a slope stability problem in the mine. Tension cracks are the result of the slope failure and can be observed at northern side of the mine.
- Tension cracks are sub-circular and show multiple stages of slope failure. Fractured blocks show horizontal and vertical movement. The inclination of these blocks varies 10–30° with N112° to N210° orientation.
