Architecture and Structures of Kiradu Temple (Barmer Region, Rajasthan, India)

Abstract Kiradu temple, known as the Khajuraho temple of Rajasthan, is an epitome of Maru-Gurjara style of architecture. Due to weathering, several sections of the temple complex has been decayed. Though several literatures have mentioned the architectural style of the Vishnu temple of Kiradu, very few work has mentioned the details of other temples existing within the temple complex. In this study we have attempted to understand the architecture and present structural condition of Kiradu. We have studied the strength analysis of one of the partially destructed temple to understand the vulnerability of the fractures. We have tried to look into different fractures and destructed artifacts to understand the real reason of their decay. This study will help us for the preservation and restoration of the temple and to understand the cultural and social lifestyle of the western India during medieval period.

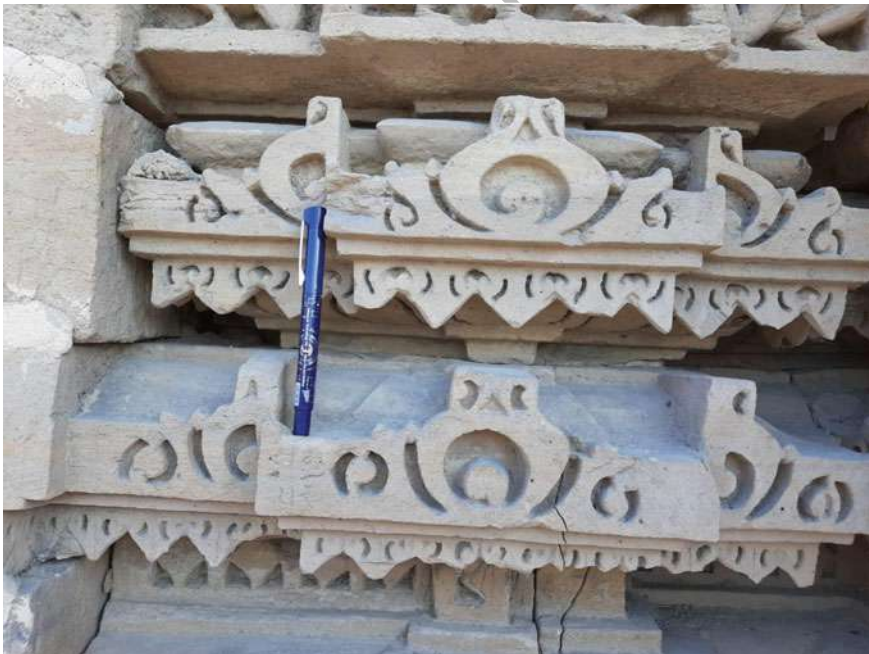
The Talchhand section is completely destroyed in the Shiva temple. Only the Garbhagriha section is remaining. We have observed that the wall of the remaining section has been fabricated based on interlocking blocks. Interlocking blocks are suited for wall constructions with loads specially for two or more storeyed constructions. The temples of Kiradu are at a height more than two storeyed building with heavily sculptures inscribed wall. So this interlocking blocking helps to keep the strength of the wall. Figure 8 shows that lower panel section is attached to the upper panel with block to block locking. Some part of the temple is under restoration (Fig. 9). Figure 9a shows that the due to weathering, the Jadyakumbha portion of the wall is damaged and restoration is performed into that section as in Fig. 9b. Adhesive (calcareous cementing material) are usually used to attach one damaged section to the main construction (Fig. 10a, b). In Fig. 10b, we can observe that the Narapitha block is broken and it is attached with the Khuraka section using calcareous cement. Figure 11 presents a wind induced erosion in the temple rock.

Fig. 8 Block to block locking system of rocks in the Shiva temple (Temple No. 1) (Pen of length 13 cm)

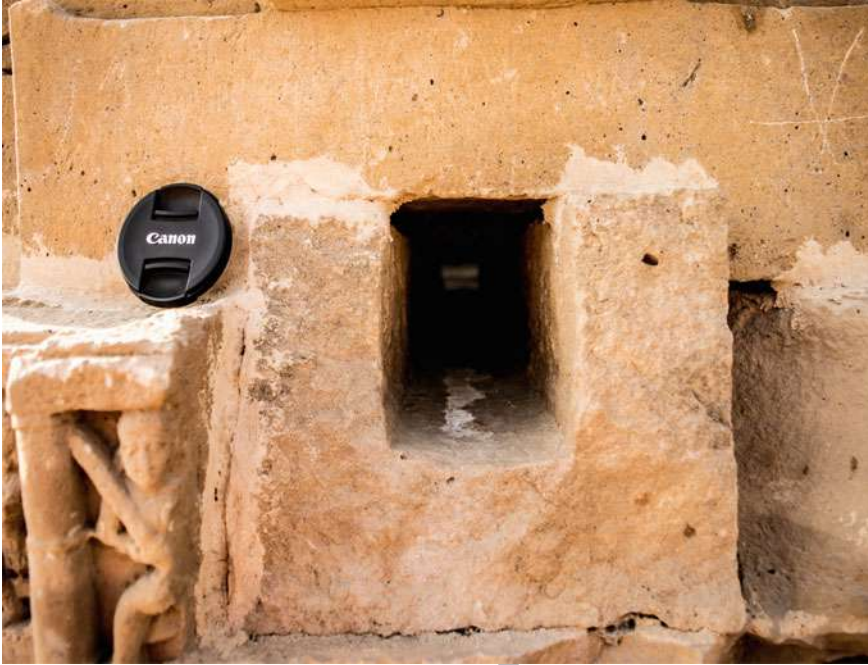
Figure 15 shows restoration work within the sandstone using calcareous cementing material. We have seen a drain of width 8.1 cm and length 20 cm in north–south direction within the garbhagriha of the Shiva temple to drain the stored water. Figure 16 indicates the water outlet in north–south direction.

Fig. 16 Water outlet along north–south direction of width 8.1 cm and length 20 cm (Temple no. 1) (Canon cap marker of diameter 5.4 cm)

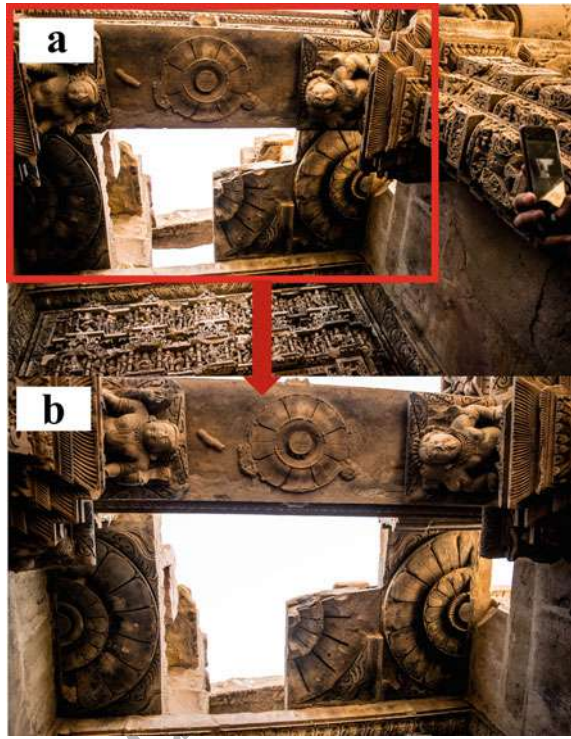
Fig. 20 Lock and key design atop the garbhagriha of the Someshwar temple (Temple no. 2). **a** Inside part of the roof over the door of the garbhagriha, **b** Lock and key design within the slab to hold the roof

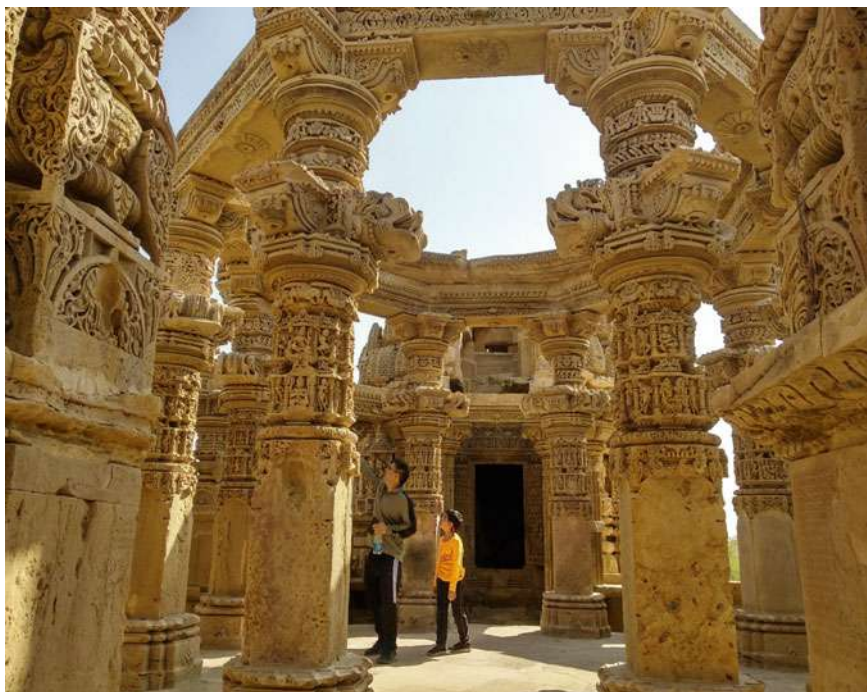
pillars. Natural fractures are also observed at the temple wall (Fig. 23a). Water-induced erosion has created ~2 cm deep cavities in sandstones, giving rise to finally honeycomb appearance (Fig. 23b). In Rep. Fig. 2, the Talchhand section (From the entry gate to the gate of Garbhagriha) is illustrated.

Rep. Fig. 2 Decorative pillars of Mahamandap and Talchhand (Temple no. 2). Soumyajit Mukherjee and Ritojit Mukherjee as markers

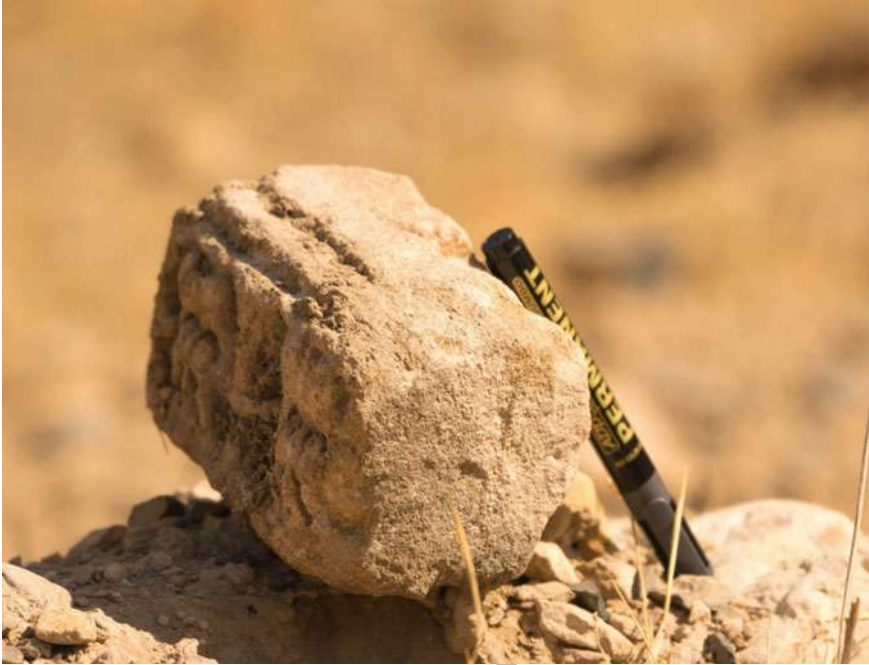
We have collected one sample foundation stone from the ruins of this temple and performed uniaxial compressive strength (UCS), transverse strength, porosity, density, abrasive strength calculation to understand the physical properties of the sample stone. Repository Figure 3 displays the sample. These physical properties are engineering properties of the building stone (Deere & Miller, 1966). Indian standard code, as per the present day norm, define the engineering criteria to select the building stone. Rock blocks used in building construction should have compressive strength between 60 and 200 N/mm² (IS9143, 1973). Similarly, specific gravity of the building stone can vary 2.4–2.8. Highly porous stone is not good for the moisture full environment condition, so, absorption should not be more than 5% and porosity should be <25% [IS 13030 (1991 reaffirmed 1996 and 2001)]. The porosity

Rep. Fig. 3 Sample collected for testing from Temple no. 2

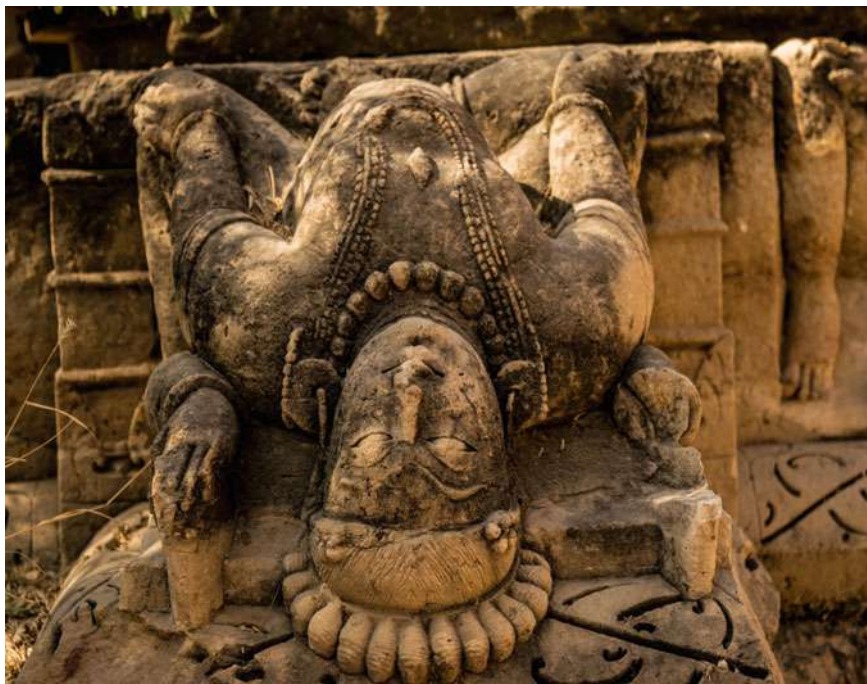
Rep. Fig. 4 A fallen idol ornamented with various jewellery (Temple no. 3)

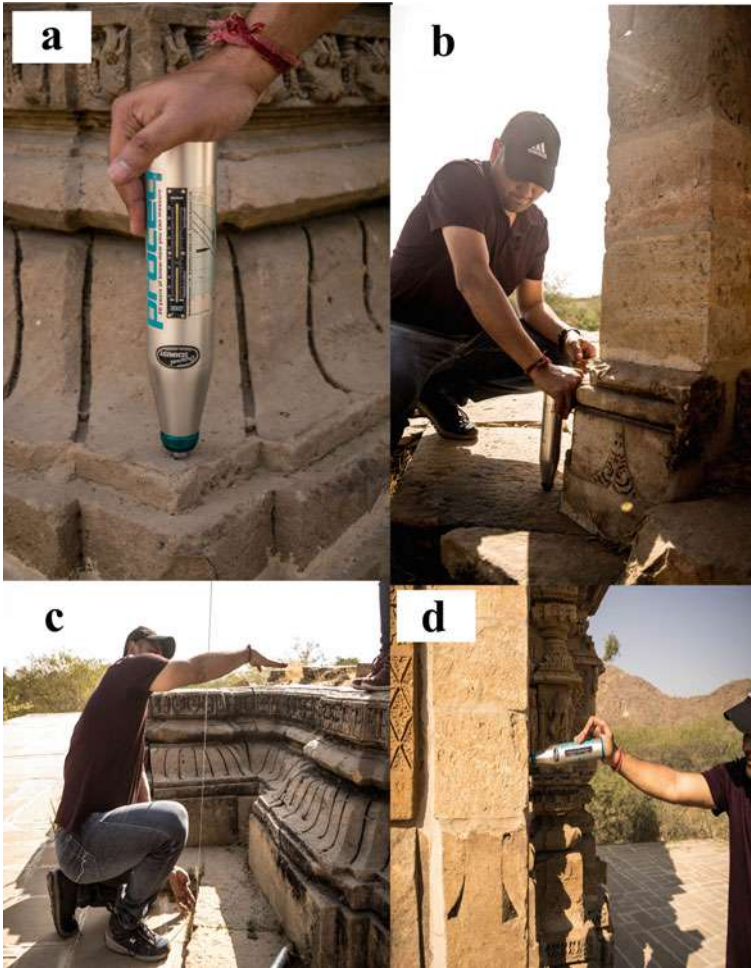
In this temple, only the garbhagriha is remaining. The remainder is completely ruined. We have measured tensile strength variation at different sections of this temple using smith hammer. The first foundation stone from the base is of 25 cm thick. The following strengths are measured in four different basement stones (measured from bottom to top), 55 N mm^{-2} , 55 N mm^{-2} , 48 N mm^{-2} and 48 N mm^{-2} , respectively. Strength of the pillar foundation base is 46 N mm^{-2} . The height of the upper base of pillar is 90 cm. Figure 28 shows strength measurement with Smith Hammer at (a) 1st Foundation stone, (b) base of the pillar, (c) base of the Garbhagriha, from Bhatta to Grasapattika. An average of the following strengths measured in three different sides of the pillar are 44 N mm^{-2} , 62 N mm^{-2} , and 51 N mm^{-2} respectively. The strength of the pillar without restoration is evaluated as 56 N mm^{-2} . The strength of the pillar just above 200 cm height from the base is measured of 40 N mm^{-2} (Fig. 28d). The same measurements are performed on the second pillar both on vertical and horizontal plane and strengths are $56\text{--}57 \text{ N mm}^{-2}$ and N mm^{-2} , respectively. Figure 29 presents the strength measurements at the pillars of the Shiva Temple in (a) vertical and (b) horizontal directions. The base of the Jagati is made up of basalt (Fig. 29d).

Fig. 28 Strength measurement with Smith Hammer at the Shiva Temple (Temple no. 4) for **a** first foundation stone, **b** base of the pillar, **c** Height (from the base of the pillar to the section where the smith hammer is kept) and strength measurement at the base of the Garbhagriha (From Bhitta to Grasapattika), and **d** strength measurement at the pillar

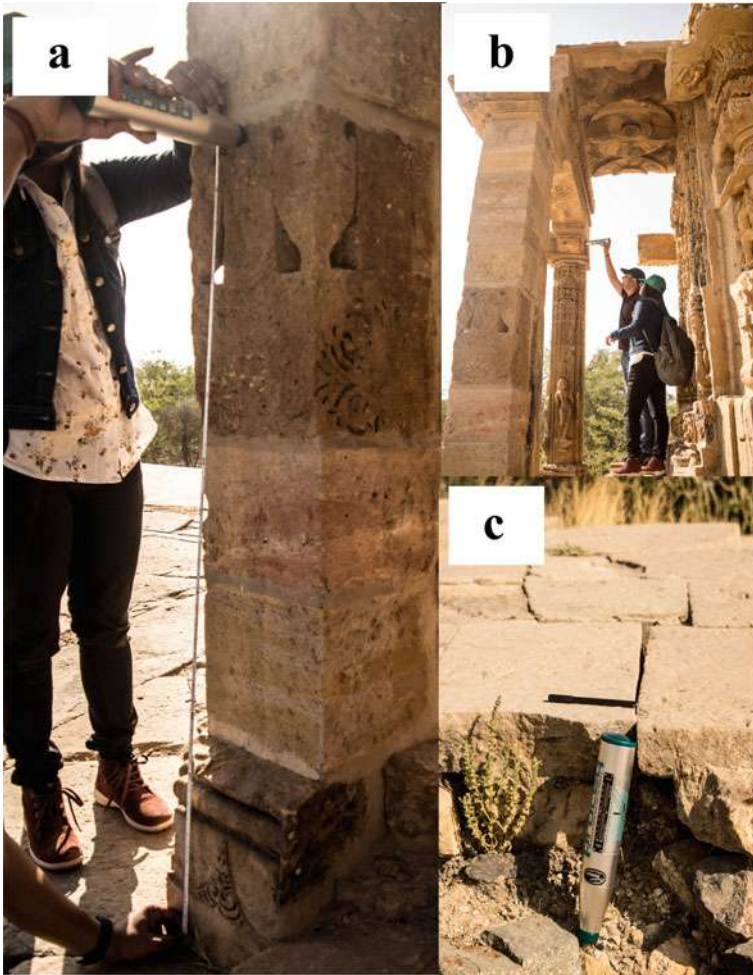
Fig. 29 Strength measurement with Smith Hammer at the pillars of the Shiva Temple (Temple no. 4) in **a** vertical direction, **b** horizontal direction, **c** Basalt base of Jagati (Smith hammer marker of length 24 cm)

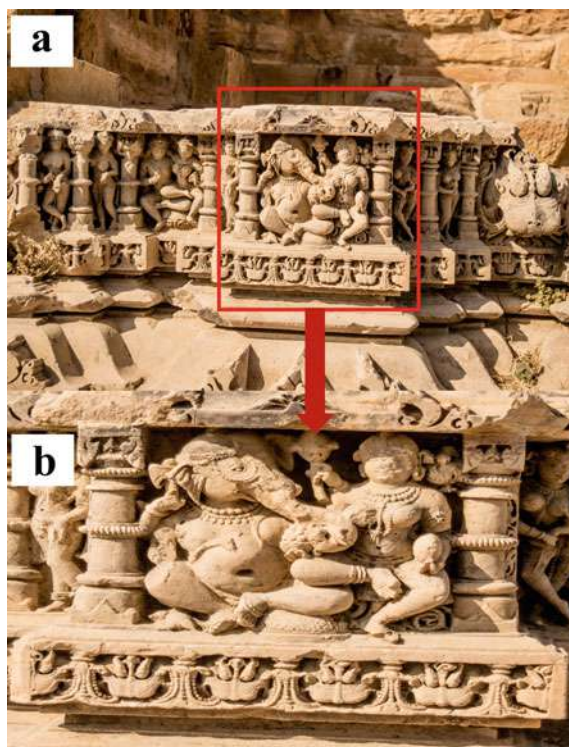
Only the Mahamandap and the damaged wall of the garbhagriha are preserved (Figs. 30 and 31). Within this temple area, several broken slabs inscribed with male and female sculptures are scattered on the ground. Figure 32a, b exhibit the scattered broken slabs of the Vishnu temple. We have visualized male “(Ganesha?)” and female sculptures in those slabs. Decorations (A warrior in the jaw of Makara) at the partially damaged pillars of the Mahamandap are also observed (Rep. Fig. 6). Detail floral motif decorations at the partially damaged pillars of the Mahamandap of the Vishnu temple are still present (Rep. Fig. 7). At the inside wall of the damaged

Fig. 32 a, b Display the broken slab of the Vishnu temple (Temple no. 6) inscribed with male “(Ganesha?)” and female sculptures

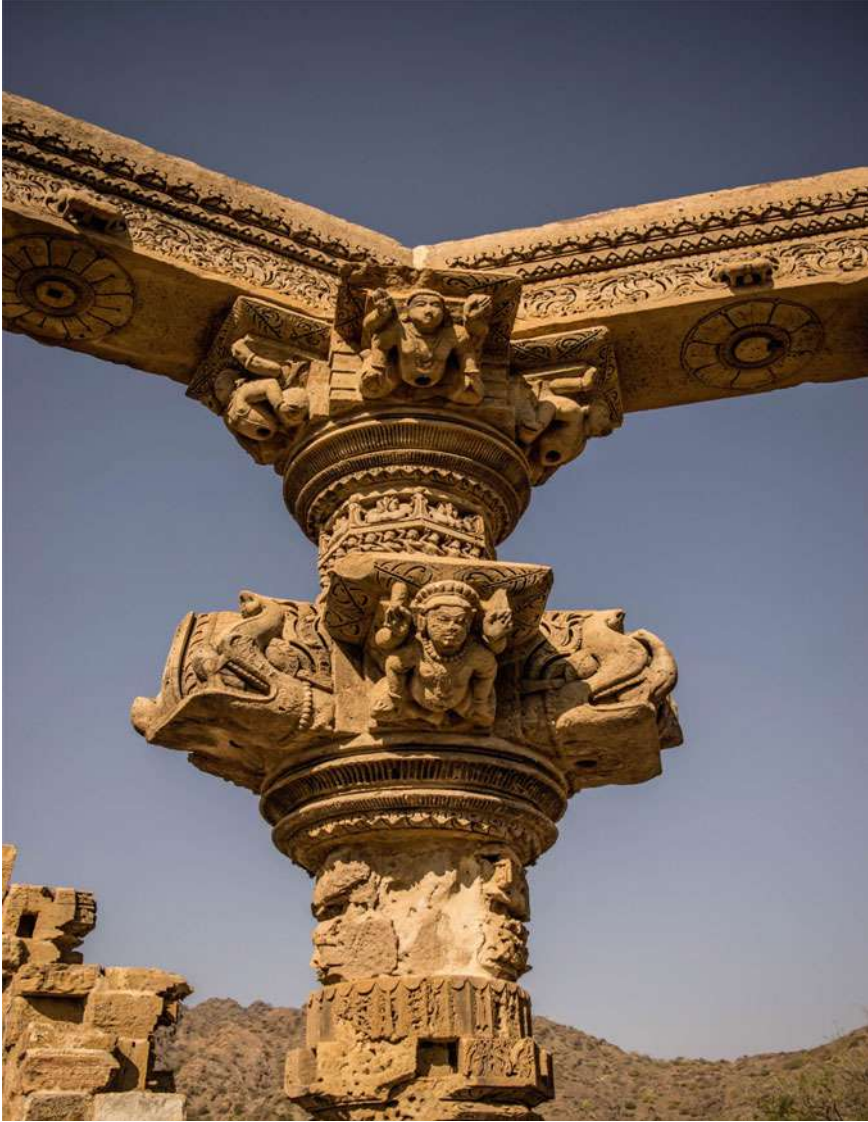
Rep. Fig. 6 Decorations (A warrior in the jaw of Makara) at the partially damaged pillars of the Mahamandap of the Vishnu temple (Temple no. 6)

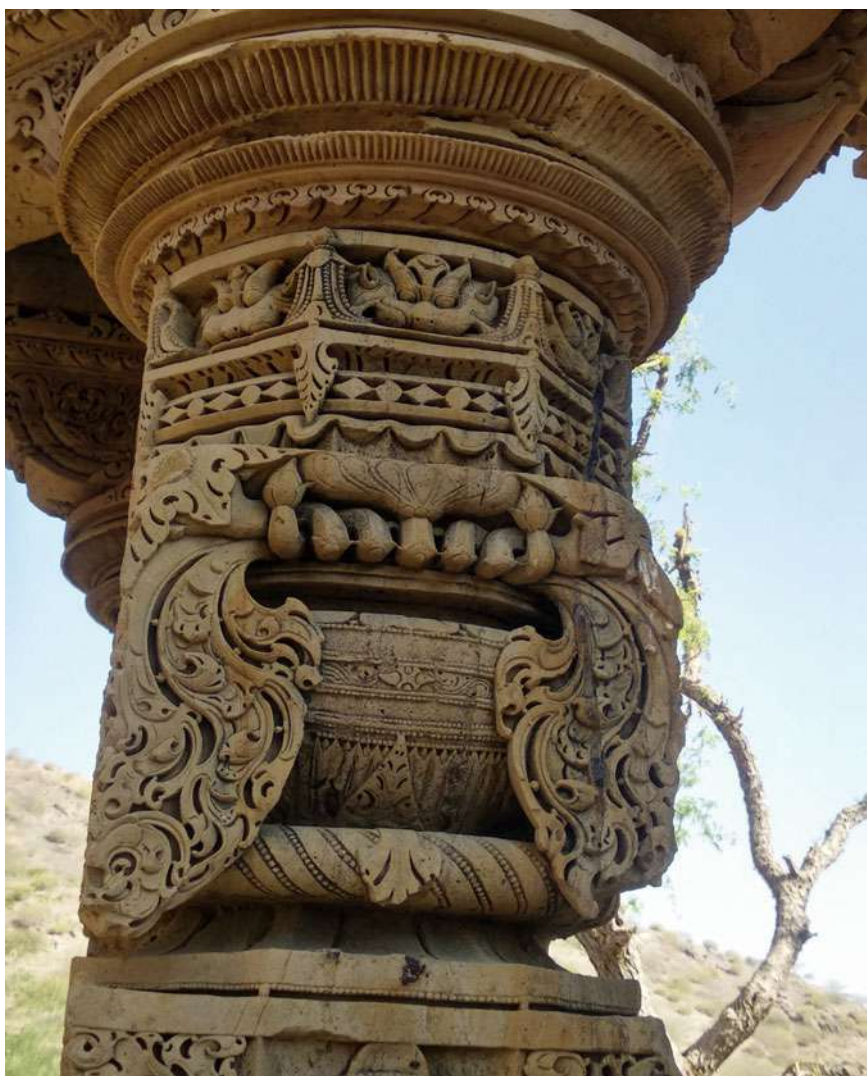
Rep. Fig. 7 Detail Decorations (Floral motif) at the partially damaged pillars of the Mahamandap of the Vishnu temple (Temple no. 6)

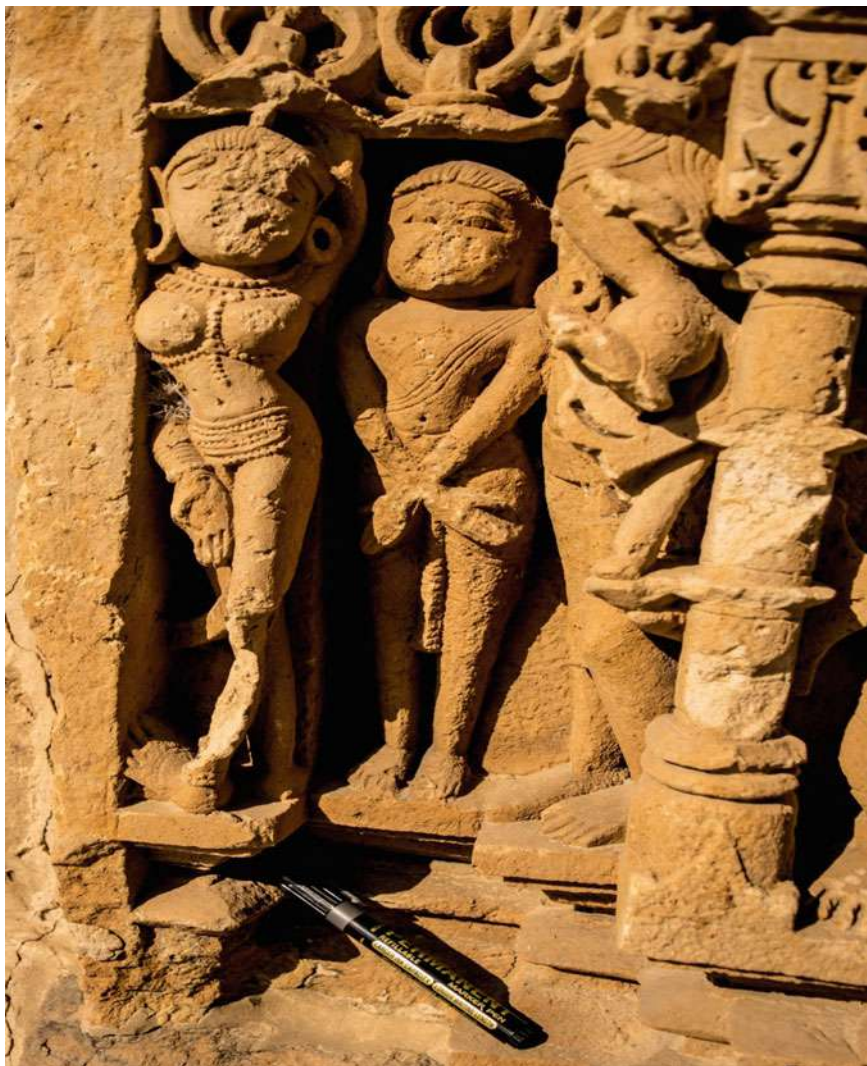
Repository Figure 9 shows another female statue vandalized at the Shiva temple (Temple no. 4). Repository Figure 9b, c and d show the vandalized sections of the female body in details. The head, hands and leg part are defaced. Repository Figures 10 and 11 exhibit that only the female statues at the wall of the Shiva temple (Temple no. 4 and 5 respectively) are damaged. From Rep. Fig. 12, the same conclusion can be reached. (Temple no. 5).

Rep. Fig. 12 At the Shiva temple (Temple no. 5) (black pen marker of length 14 cm)
